Annual Rehabilitation Report

Galong, NSW

2022

Name of Mine	Galong Limestone Mine
Titles/Mining Leases	ML 1496 and ML 1745
ARR Commencement 17 May 2021 ARR Completion 16 May 2022	
Name of Leaseholder	Graymont (NSW) Pty Ltd Lot 342 Eubindal Road Galong NSW 2585 Ph 02 6380 5100 Fax 02 6380 5199
Reporting Officer Title Signature and Date	Mr Wayne Trenning Plant Manager, Galong
Environmental Co-ordinator Title Signature and Date	Ms Nicole Sullivan HSE Specialist   14/07/2022

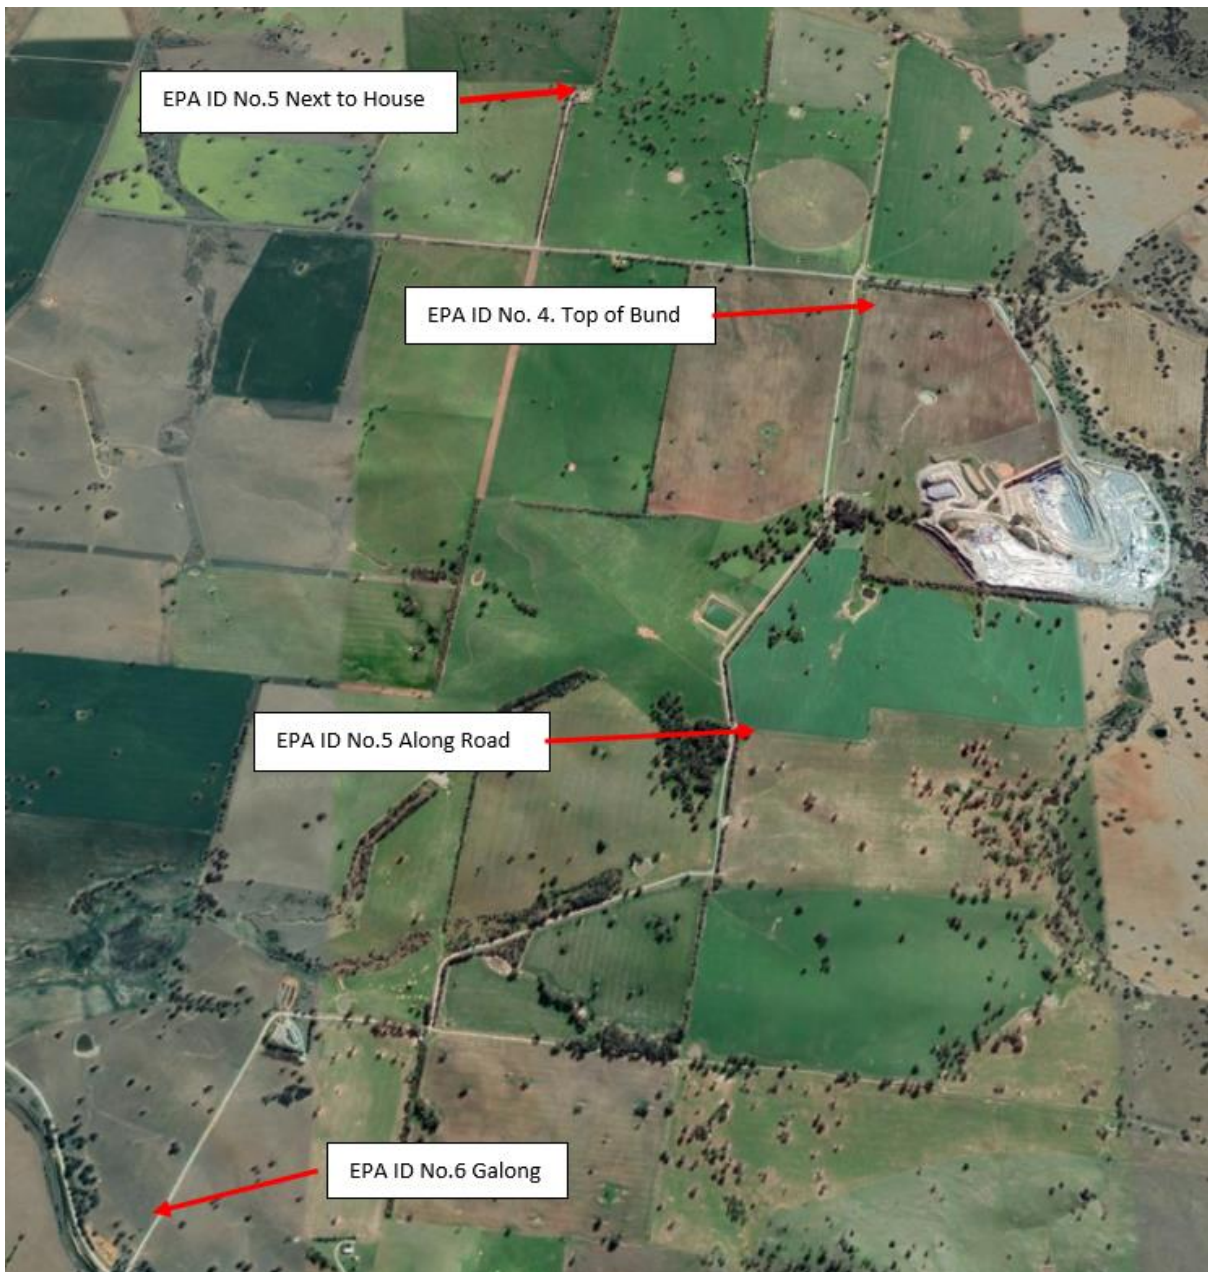
Appendix B – Dust Stations

Legend:	EPA ID	3	DG1	Top of Bund
	EPA ID	4	DG2	Next to House
	EPA ID	5	DG3	Along Road
	EPA ID	6	DG4	Galong

The HSE Specialist role has now been filled and monitoring requirements are included in the ECATS system which is now operational. A map detailing the 4 dust deposition gauges located outside the mining lease on Bobbara Station land is provided as Appendix B. The deposition gauges are listed below: A map detailing the 4 dust deposition gauges located outside the mining lease on Bobbara Station land is provided as Appendix B. The deposition gauges are listed below:

- DG1: *Top of Bund*
- DG2: *Next to House*
- DG3: *Along Road*
- DG4: *Galong*

Two of the four gauges, DG2 and DG3, are positioned to measure dust exposure to the closest community receptors. DG1 is the closest to the mine and is used to determine the level of dust generated from the mine. DG1 is also a reference station for DG2, and the comparison of the two stations assists in determining the source of dust being generated along the North-West and South-East prevailing wind quadrants. DG4 is a background station, and is the closest location to Galong village, and is used to determine if dust is a regional event and therefore not related to the site.

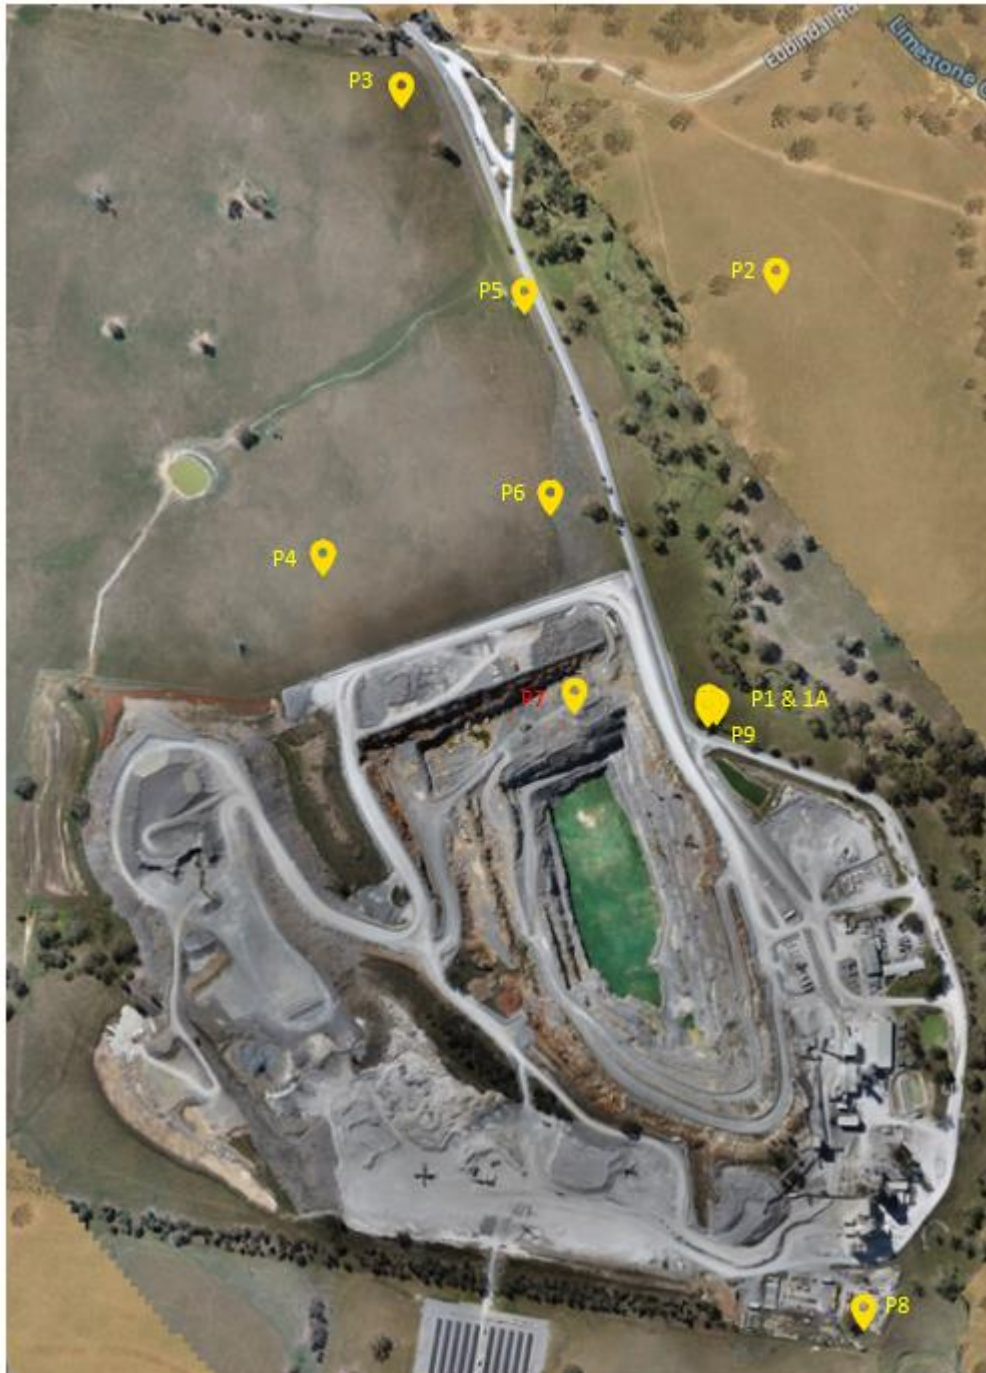
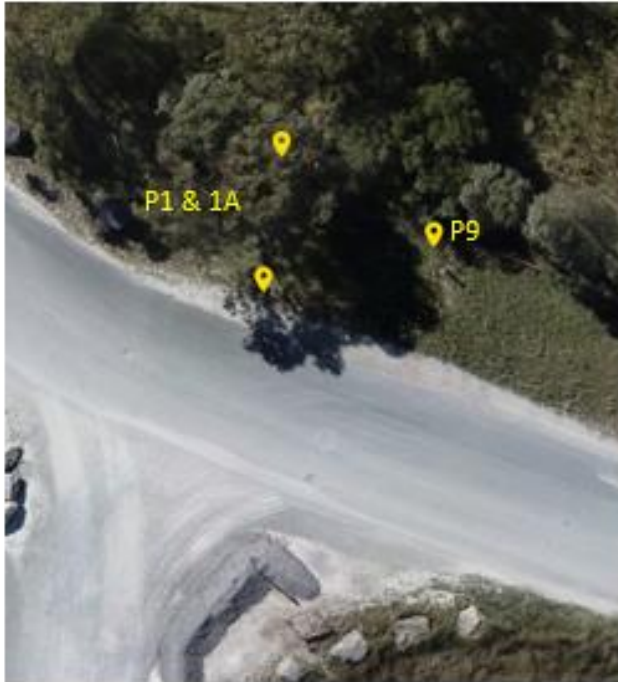
Appendix D – Piezometer Locations

Site	Alternative name	East	North	RL
P1		647186	6171618	502.12
P1A	GP191	647187	6171623	503.23
P2	GP162	647266	6172083	500.57
P3	GP130	646870	6172277	505.25
P4	GP135	646786	6171782	512.48
P5	GP144	647006	6172063	498.97
P6	GP157	647027	6171846	504.50
P7	A12	647046	6171635	502.75
P8	GP190	647339	6170983	512.32
P9	GP192	647195	6171620	502.63

Piezo Point 7 is no longer operational
