GRAYMONT

Rehabilitation Management Plan (RMP)

Excelsior Limestone Mine

Date
18 April 2024

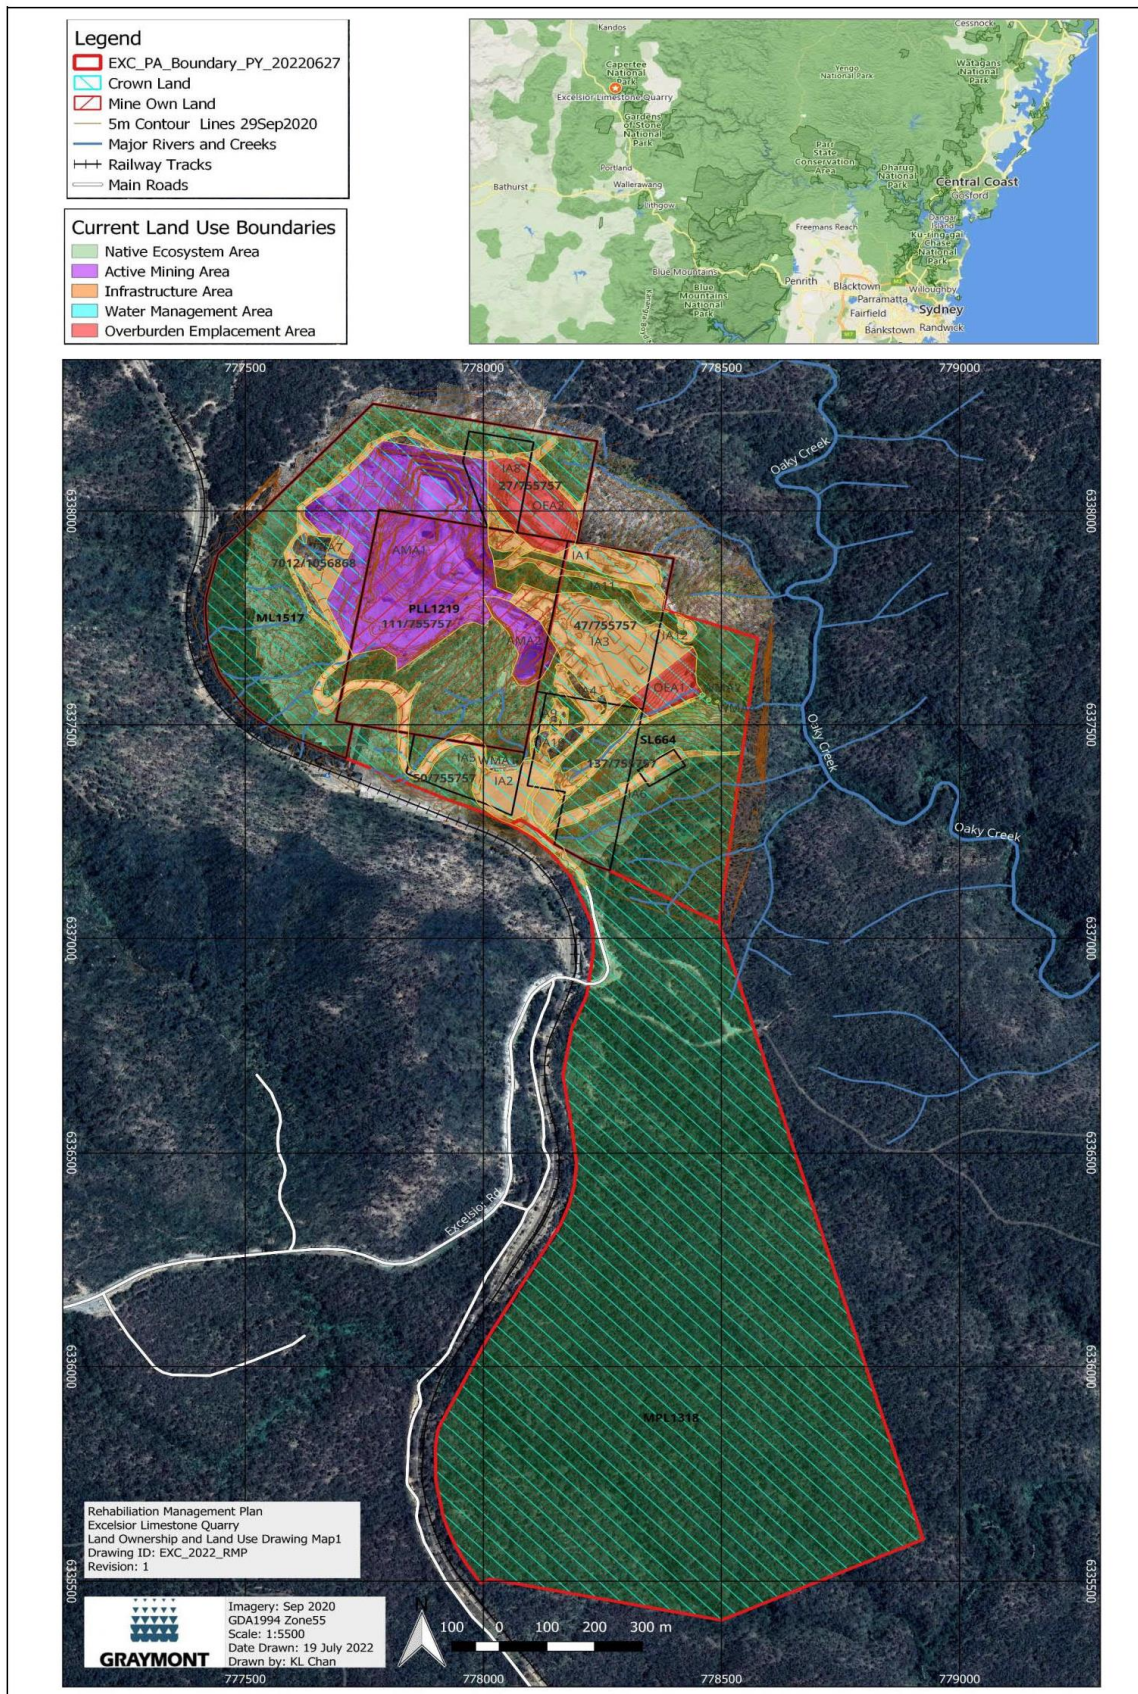
Figure 1: Land ownership and land use

Figure 1 describes the land ownership and land use in proximity to the mine site.

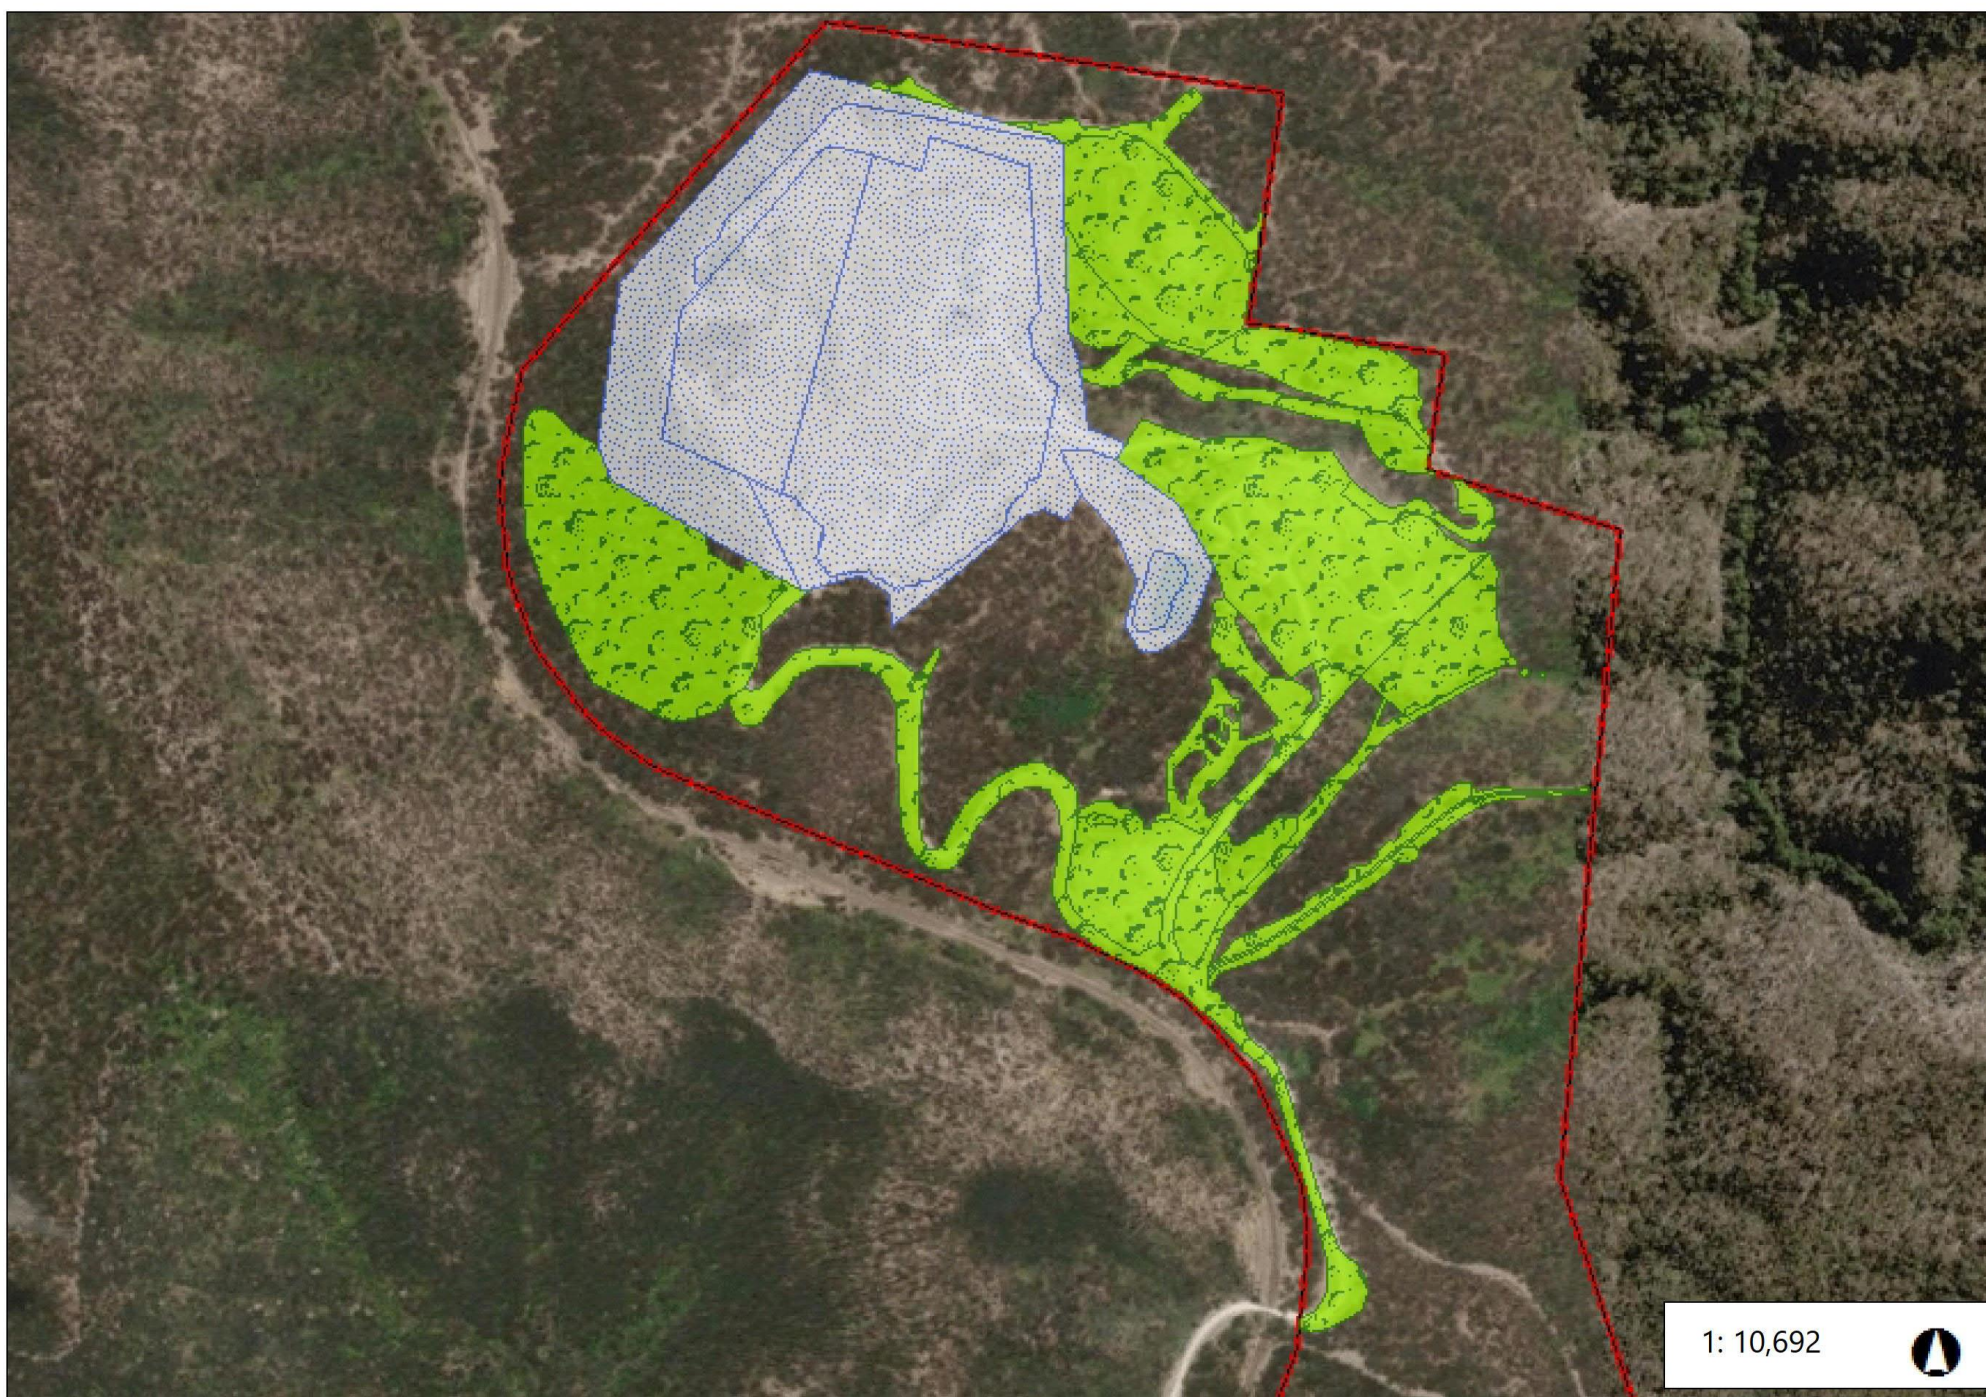
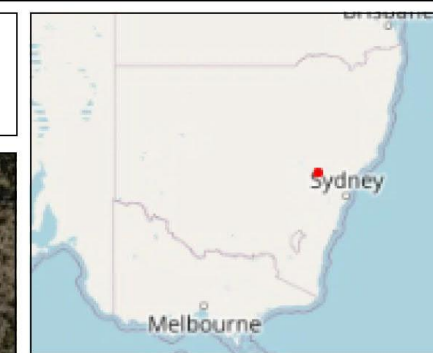
Figure 2 Final landform and rehabilitation plan - Final land use

Excelsior Limestone Mine, FLRP Plan 1A: Final Land Use

Year 2051

Figure 2 to Figure 5 provide copies of the approved final landform and rehabilitation plans submitted to the mine rehabilitation portal. Specifically, these Figures depict:

- Final Land Use (Figure 2)
- Final Landform Features (Figure 3)
- Current Authorisations (Figure 4)
- Final Landform Contours (Figure 5).

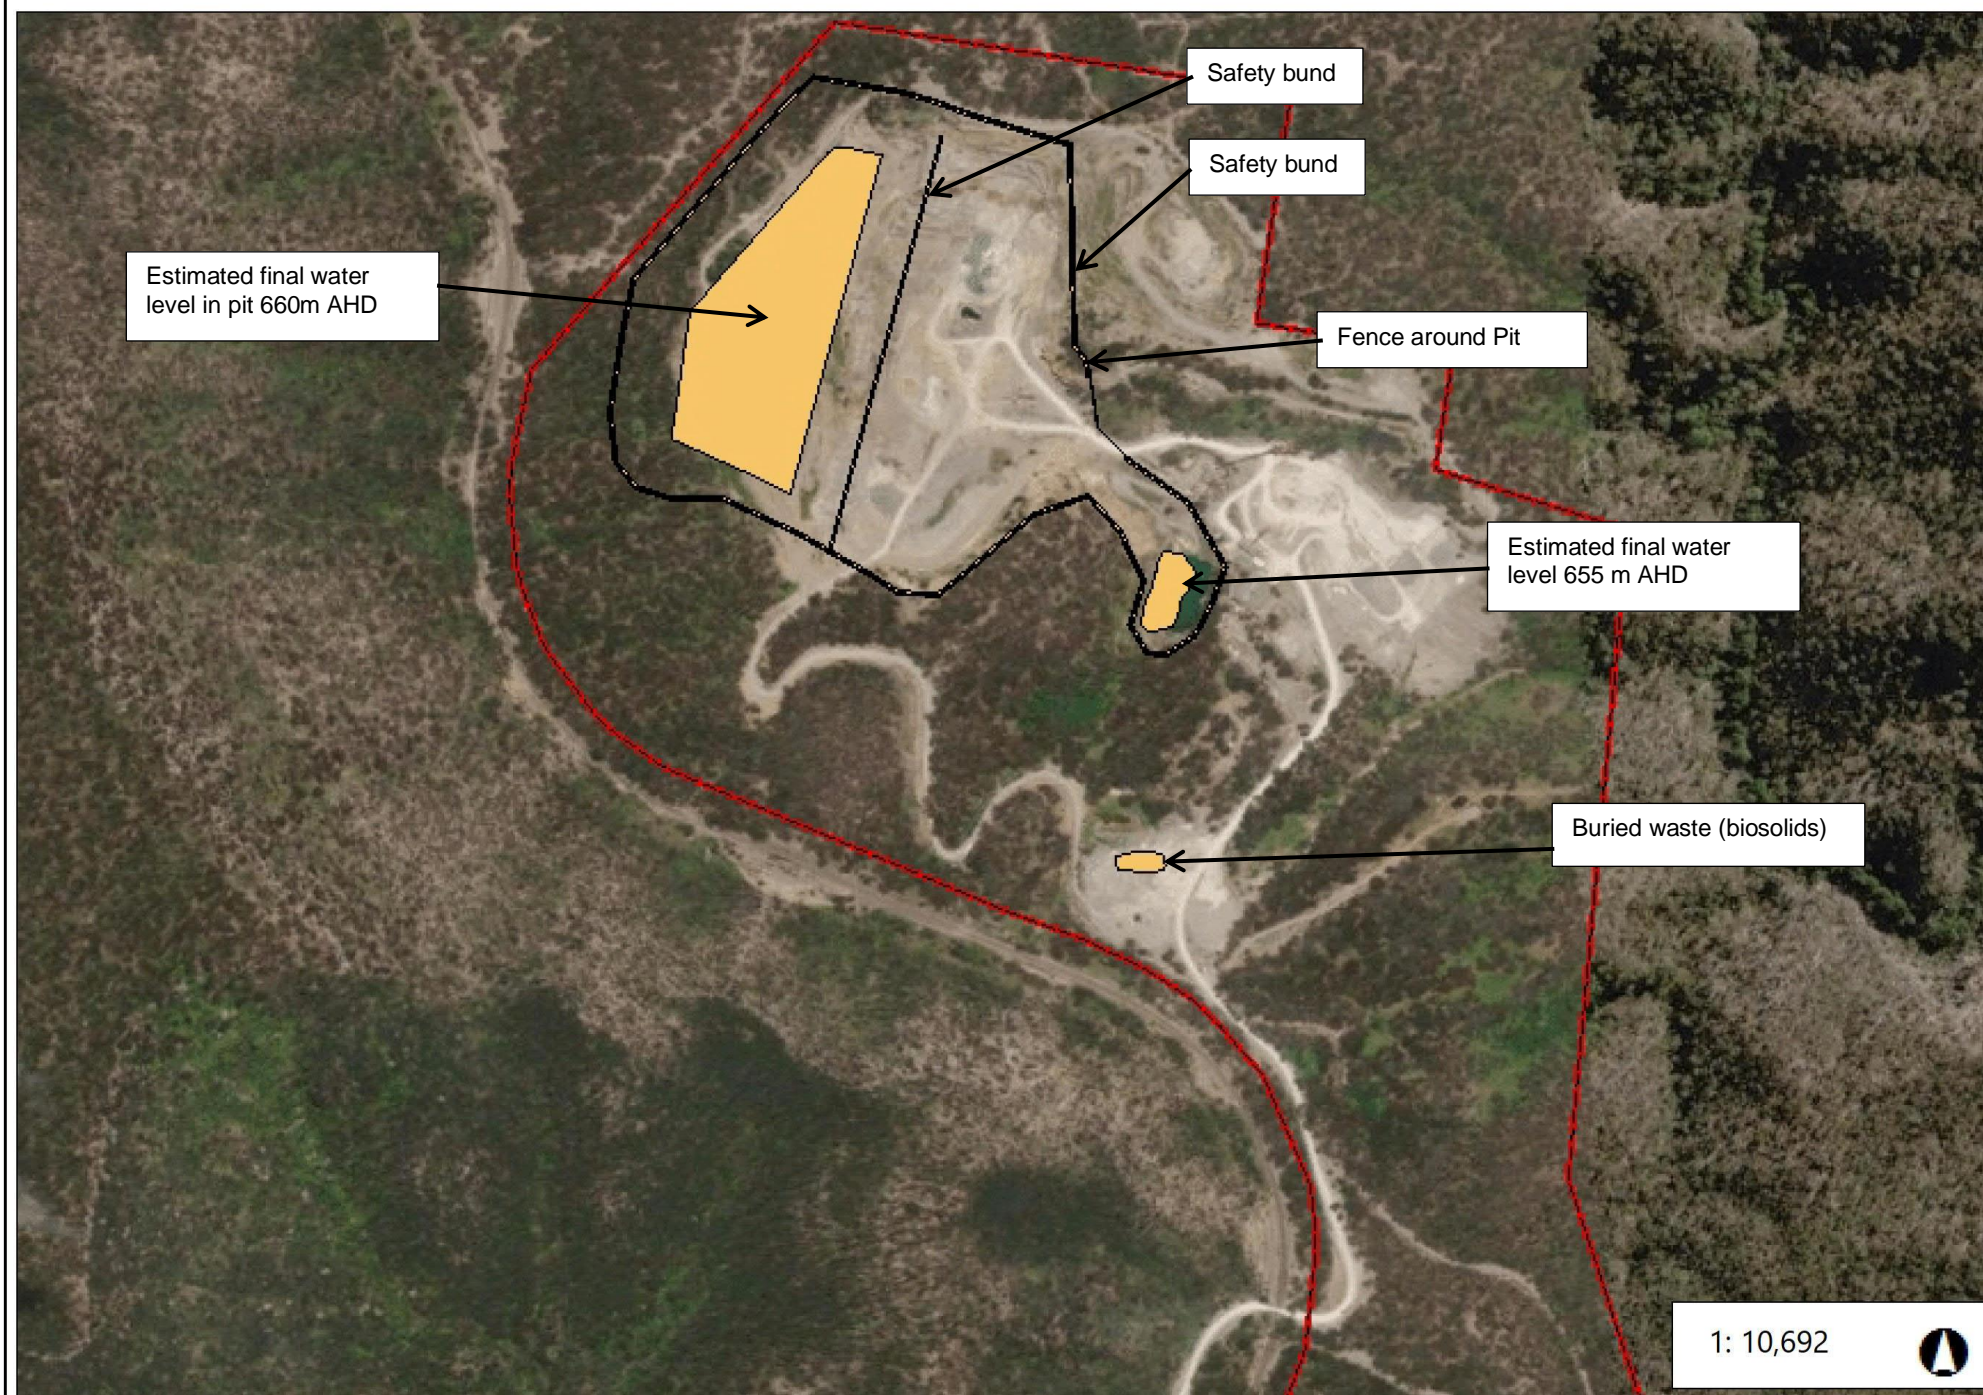
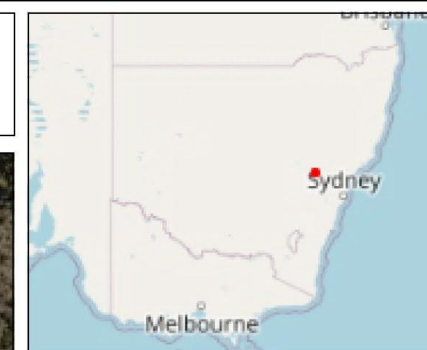
Figure 3 Final landform and rehabilitation plan - Final landform features

Excelsior Limestone Mine, FLRP Plan 1B: Final Landform Features

Year 2051

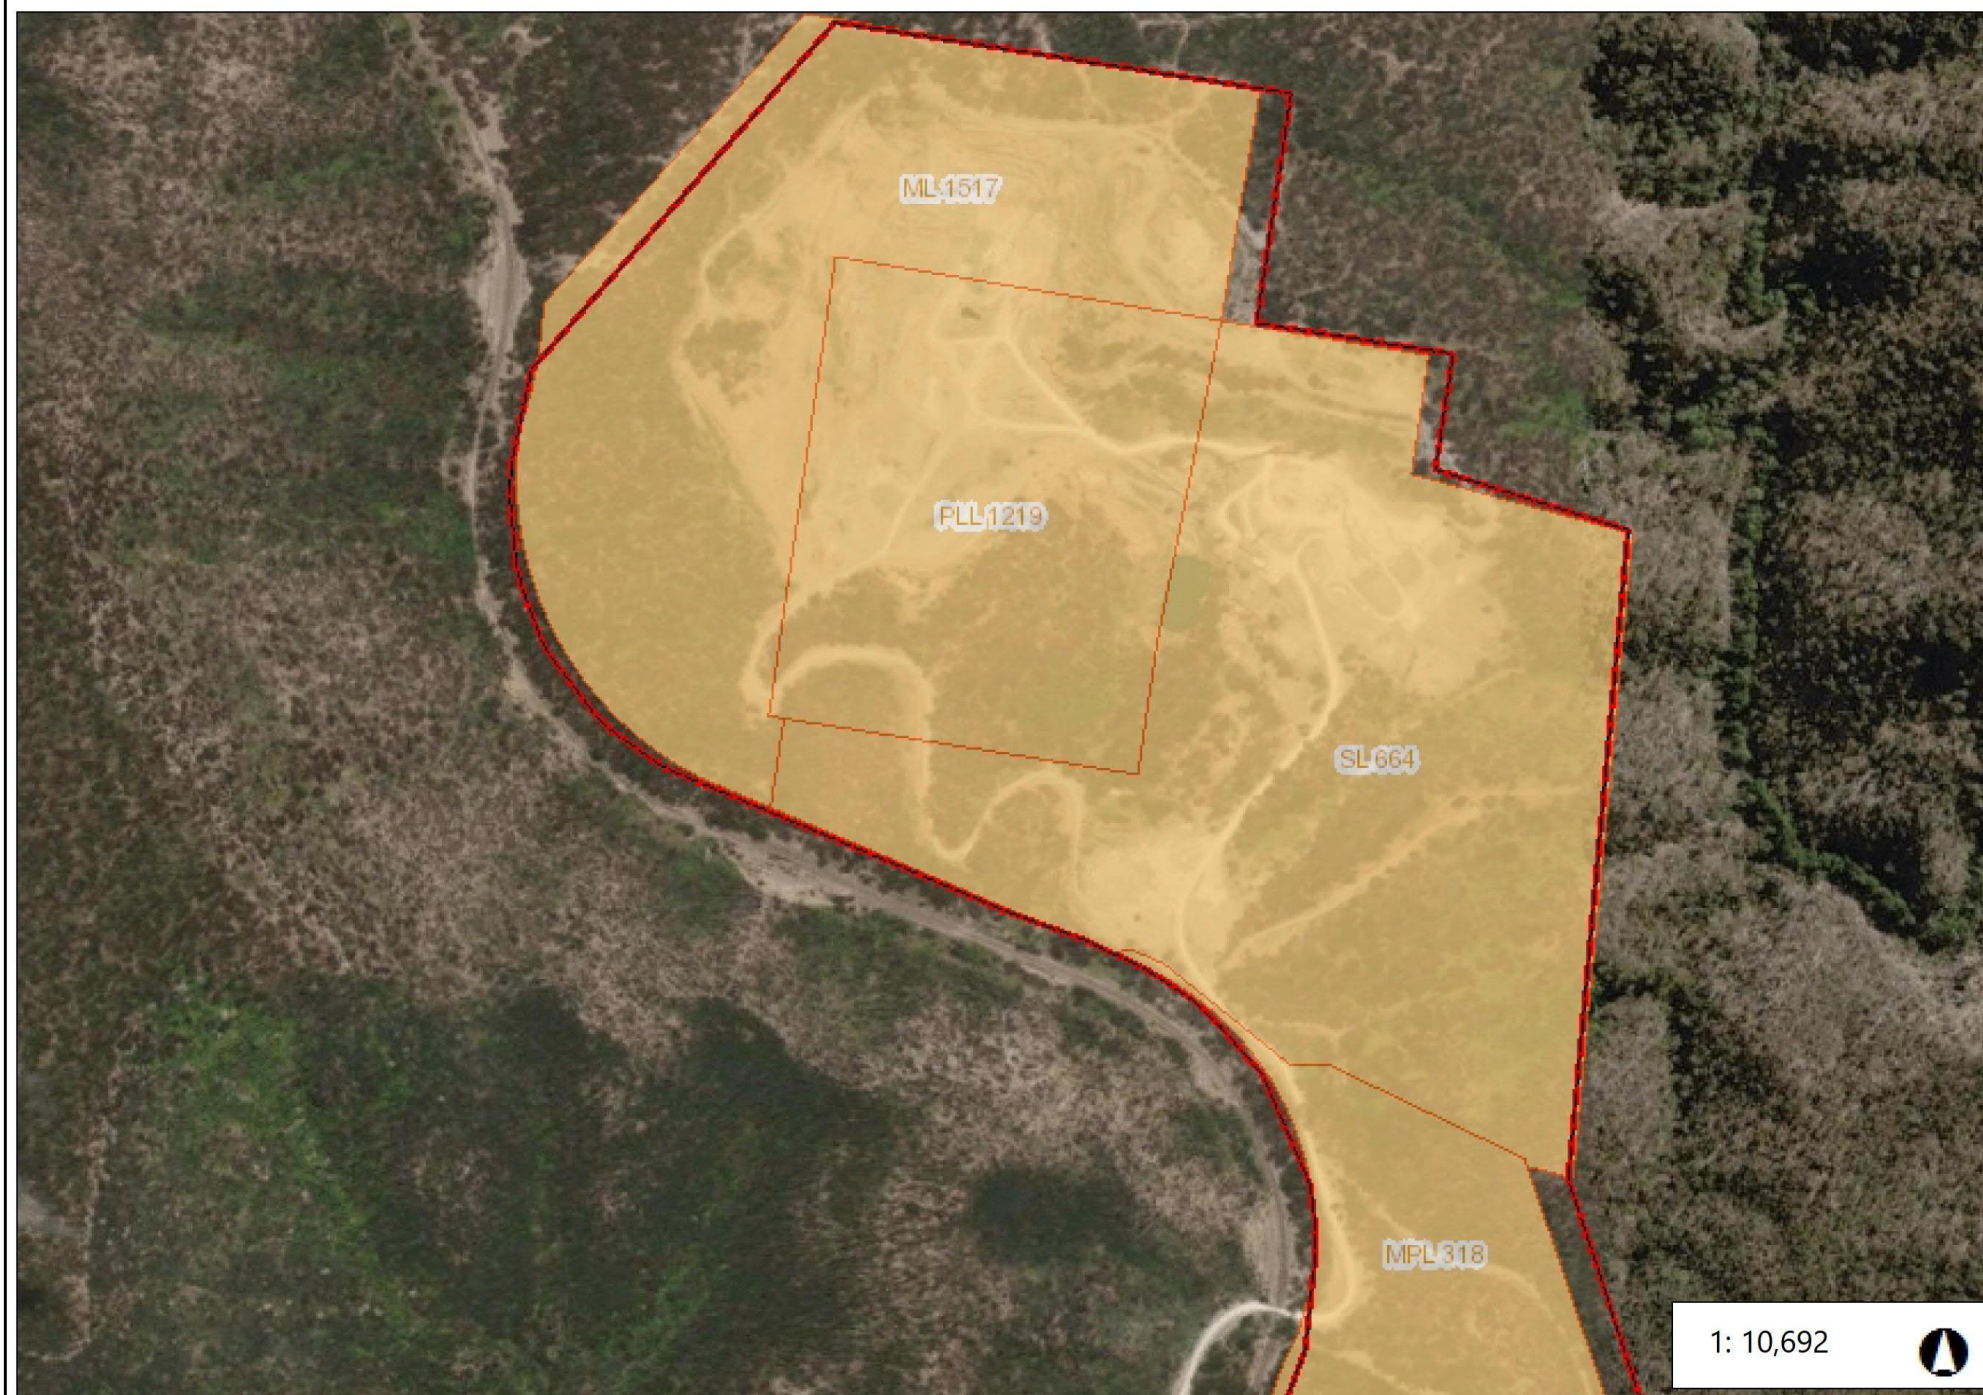
Figure 4 Final landform and rehabilitation plan – Current authorisations

Year 2051

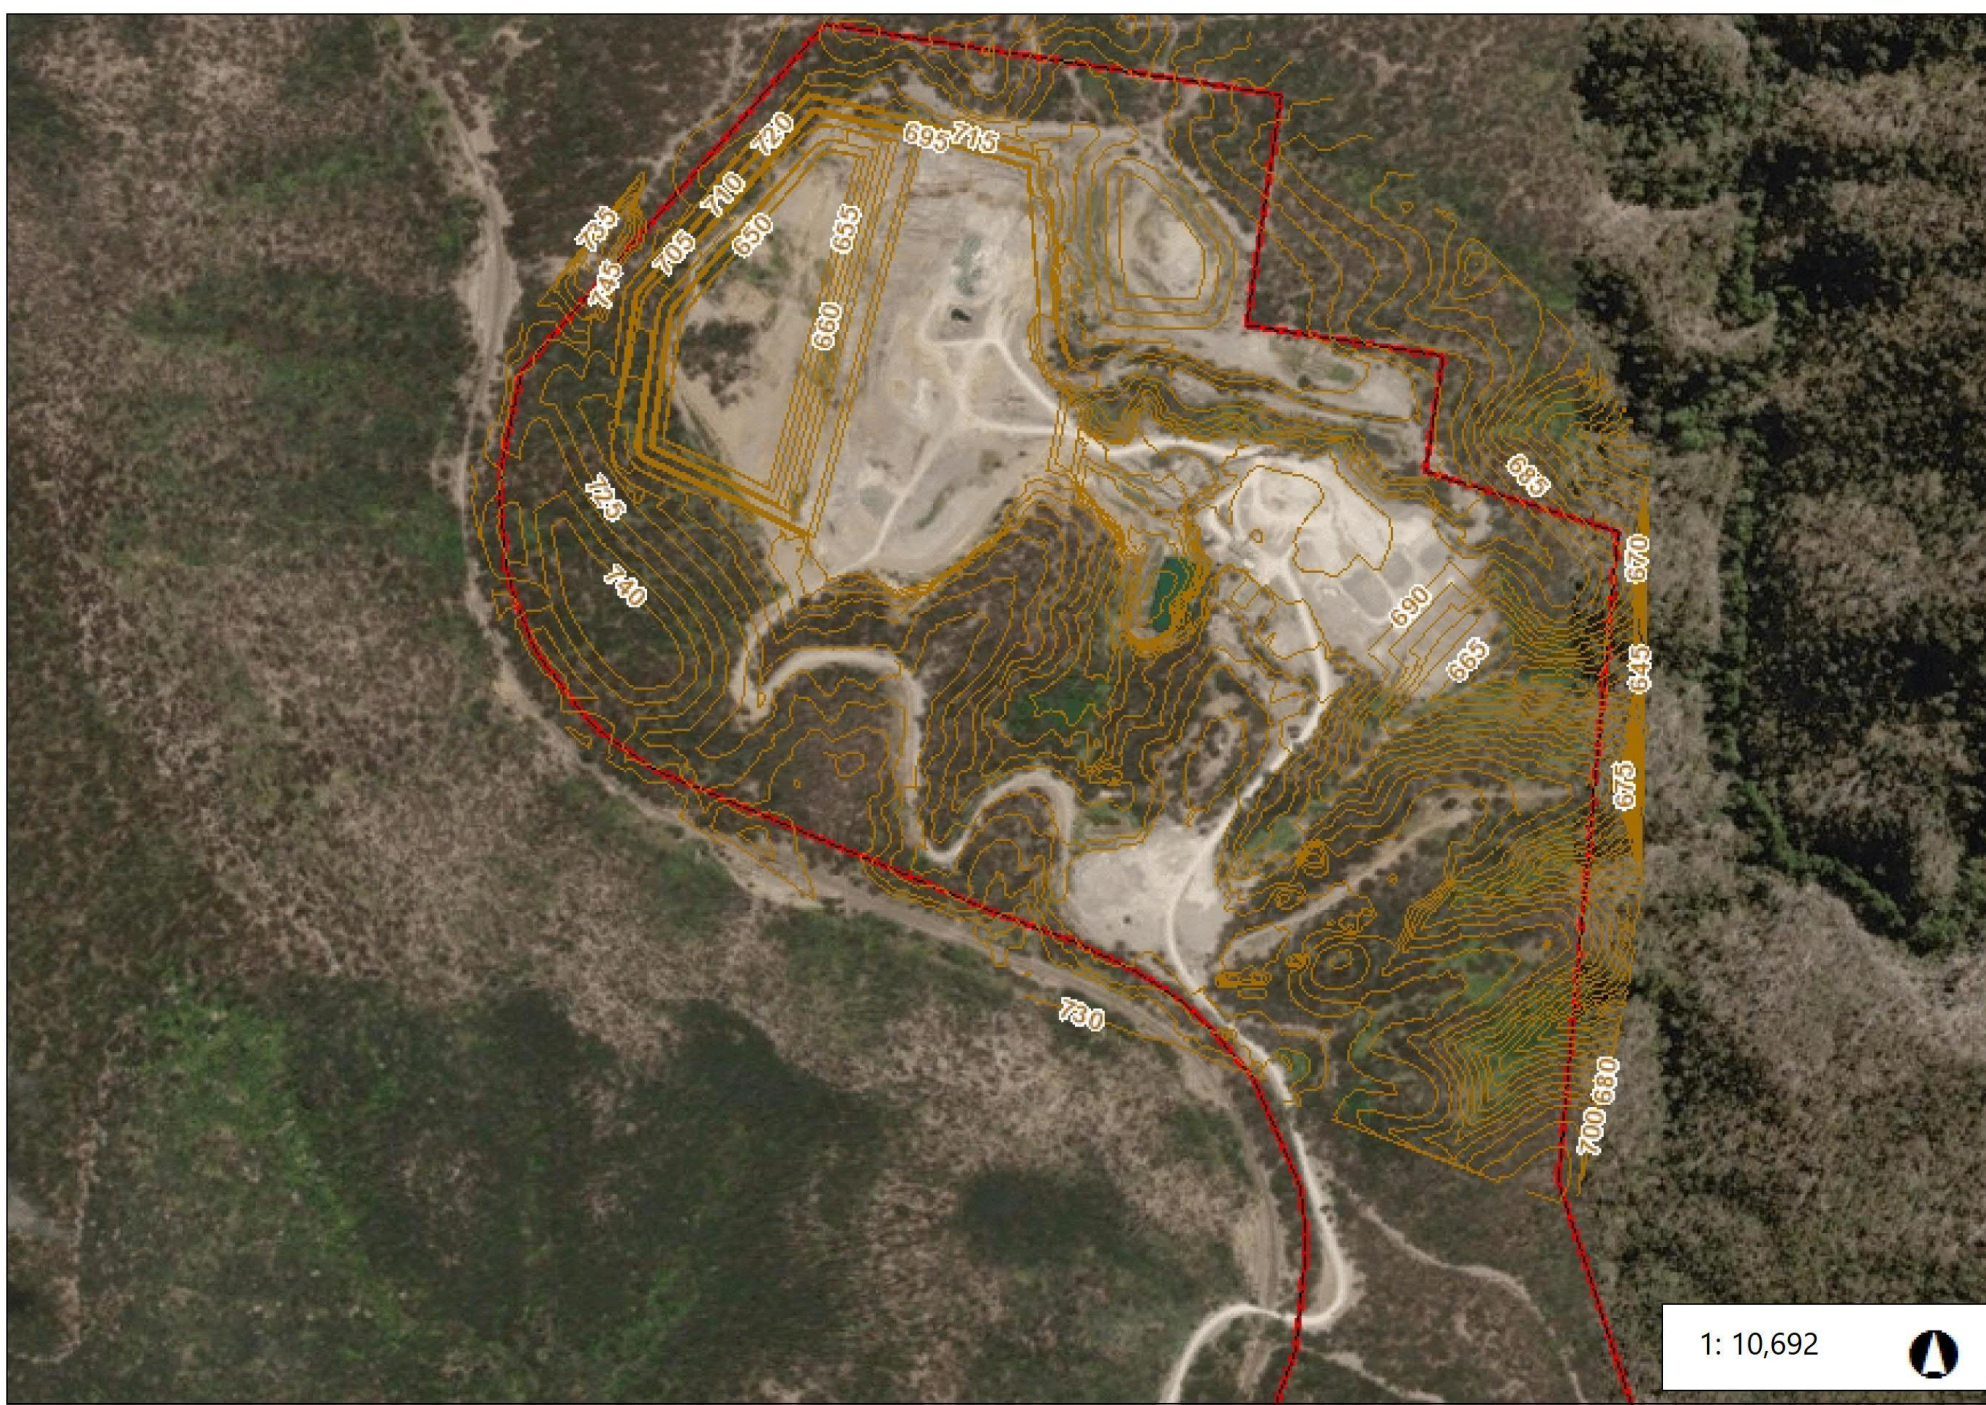
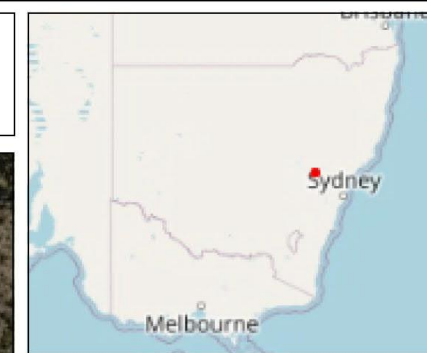
Figure 5 Final landform and rehabilitation plan - Final landform contours

Excelsior Limestone Mine, FLRP Plan 2: Final Landform Contours

Notes
Year 2051

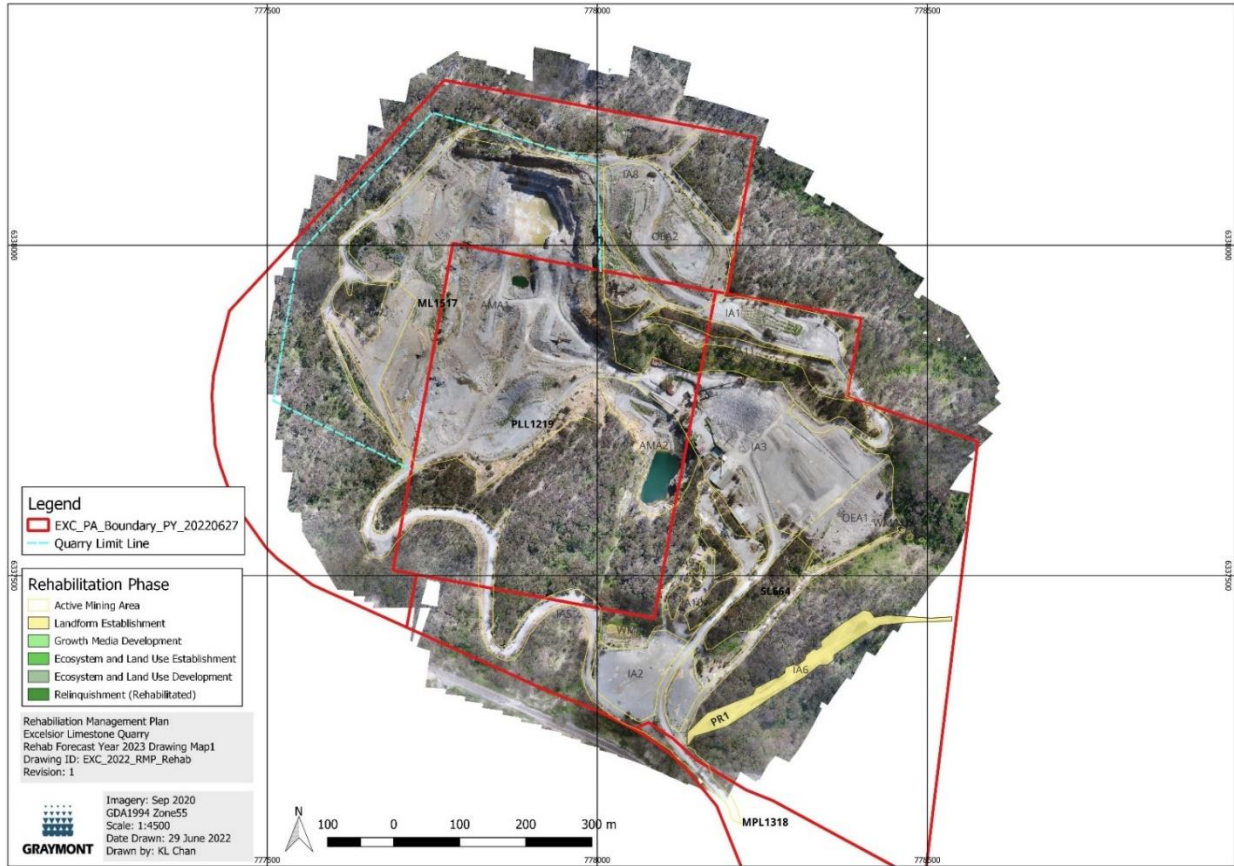
Figure 6: Rehabilitation by the end of 2023

The infrastructure area (IA6) will commence the landform establishment phase in 2023, refer to Figure 6. This area represents an internal road.

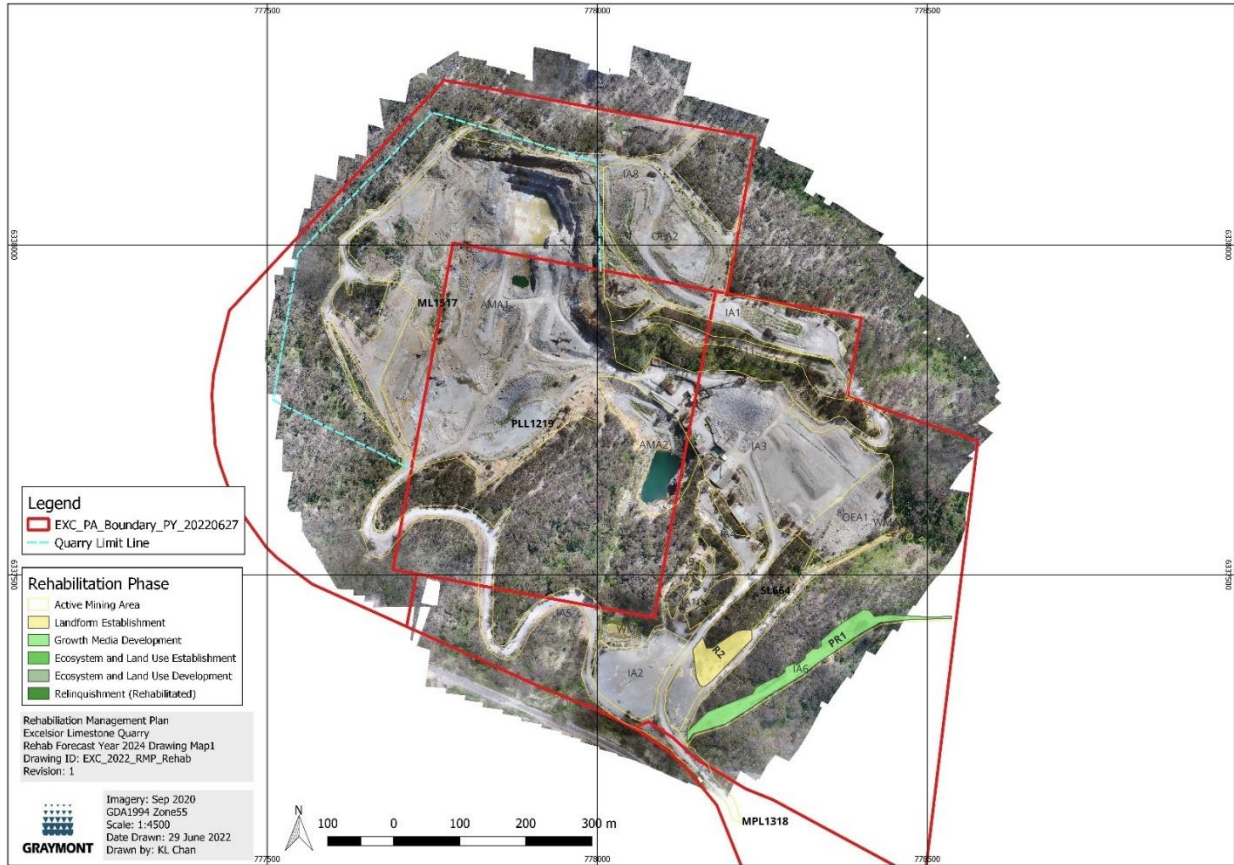
Figure 7: Rehabilitation by the end of 2024

The infrastructure area (IA6) will progress to the growth media development phase, while the infrastructure area (IA5) marked in the figure as R2 will commence the landform establishment phase.

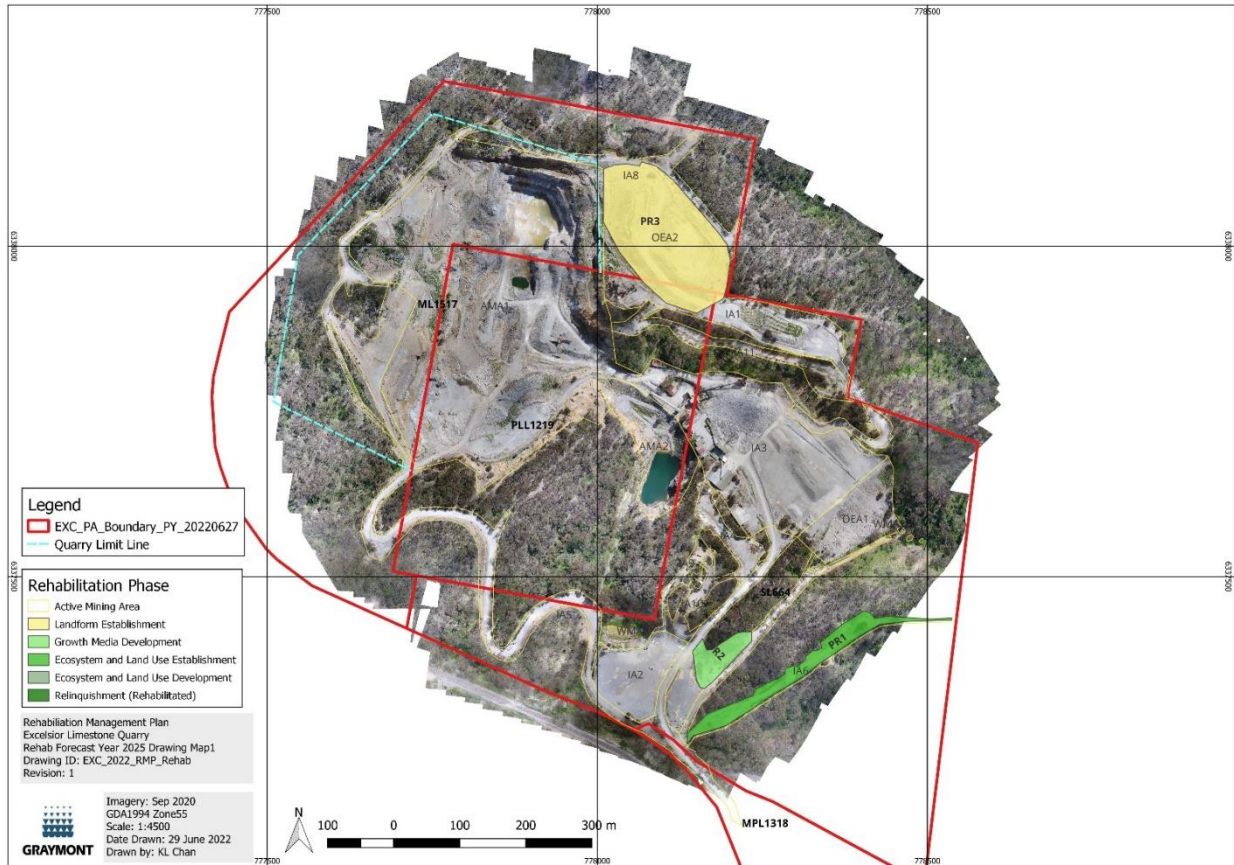
Figure 8: Rehabilitation by the end of 2025

IA6 is expected to proceed to the ecosystem and land use establishment phase by this year, while R2 is likely to move to growth media development. Overburden Emplacement Area (OEA2) will commence with the landform establishment phase and involves reshaping of the existing overburden emplacement.

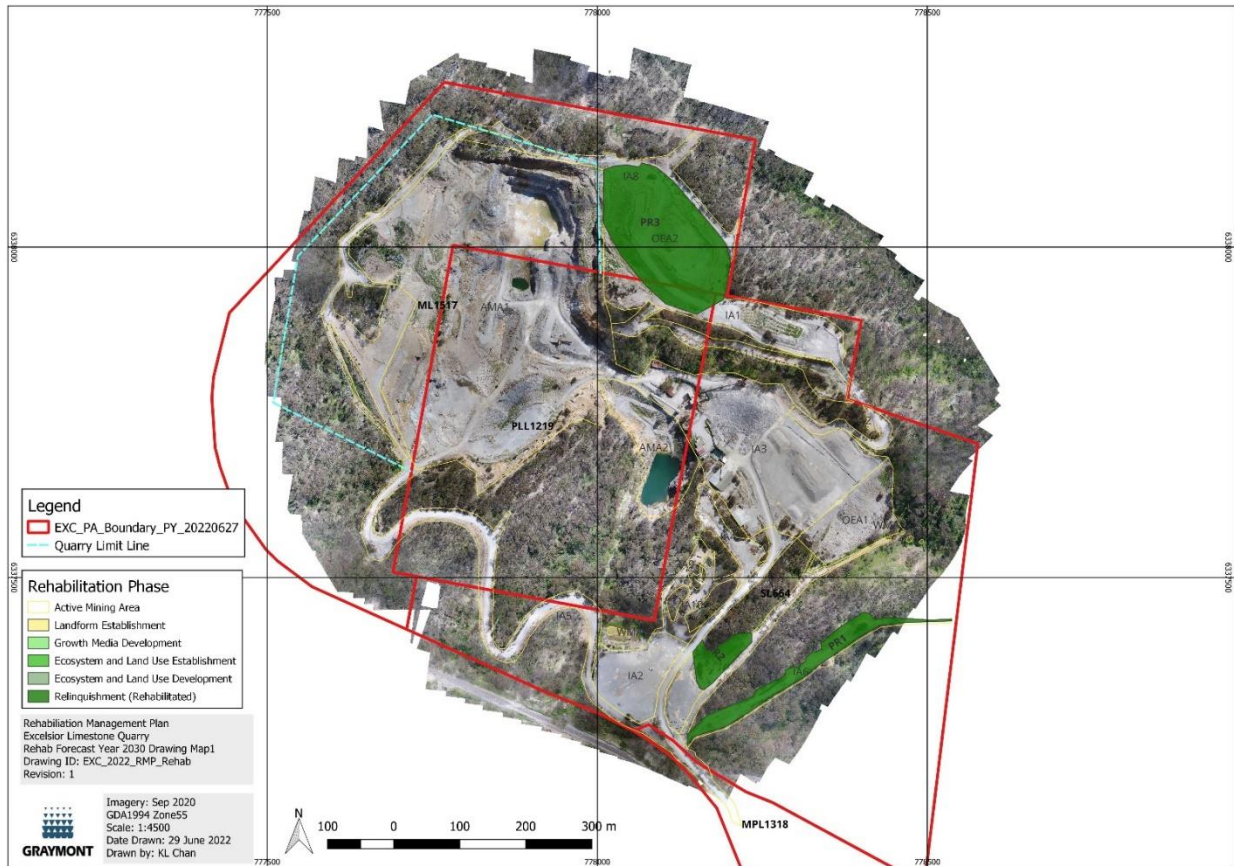
Figure 9: Rehabilitation by the end of 2030

IA6 is expected to achieve rehabilitation completion by 2026. R2 is scheduled to enter the ecosystem and land use establishment phase in 2026 and be completed by 2027. OEA2 is intended to begin the growth media development phase by 2026, progress to the ecosystem and land use establishment and development in 2027 and achieve rehabilitation completion by 2028.

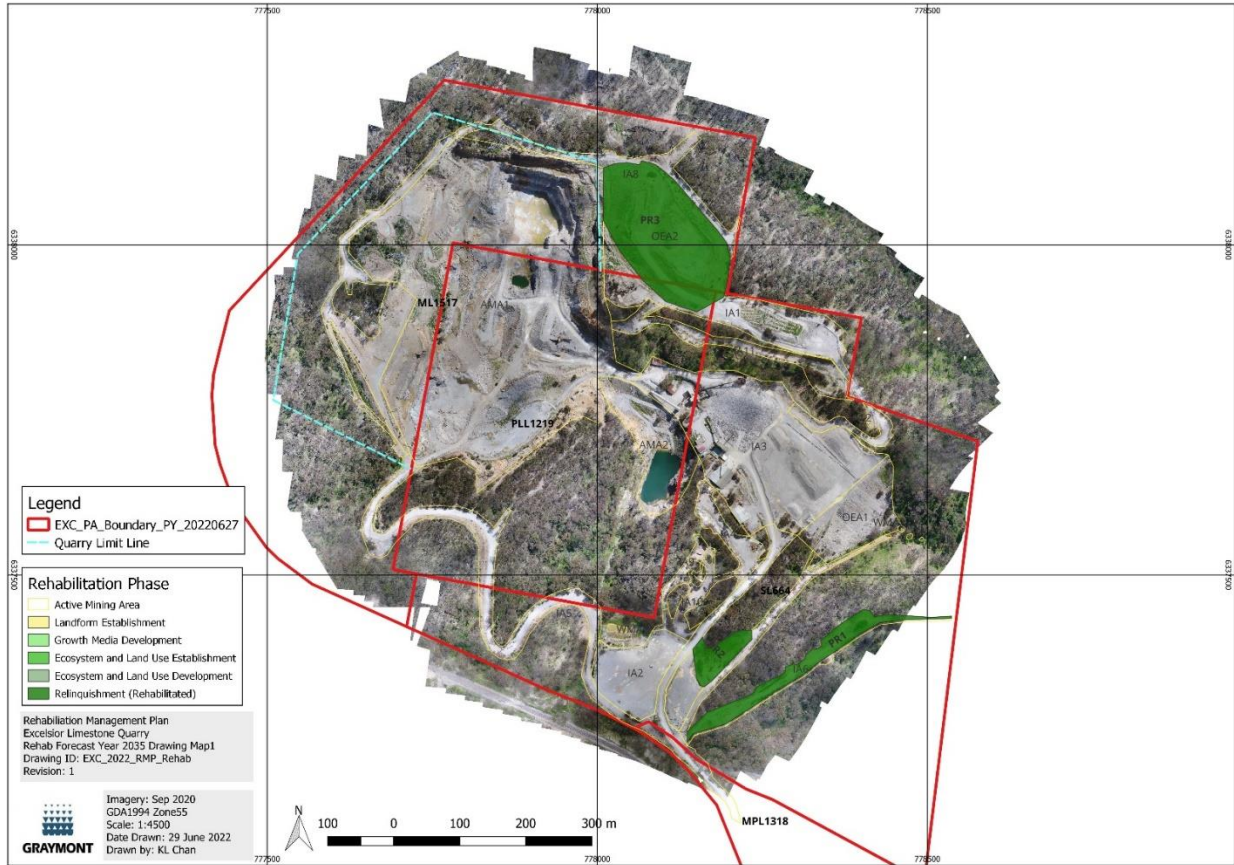
Figure 10: Rehabilitation by the end of 2035

No further rehabilitation occurs during this time. However, rehabilitation monitoring and maintenance work will continue during this time as per Chapter 8 of this document.

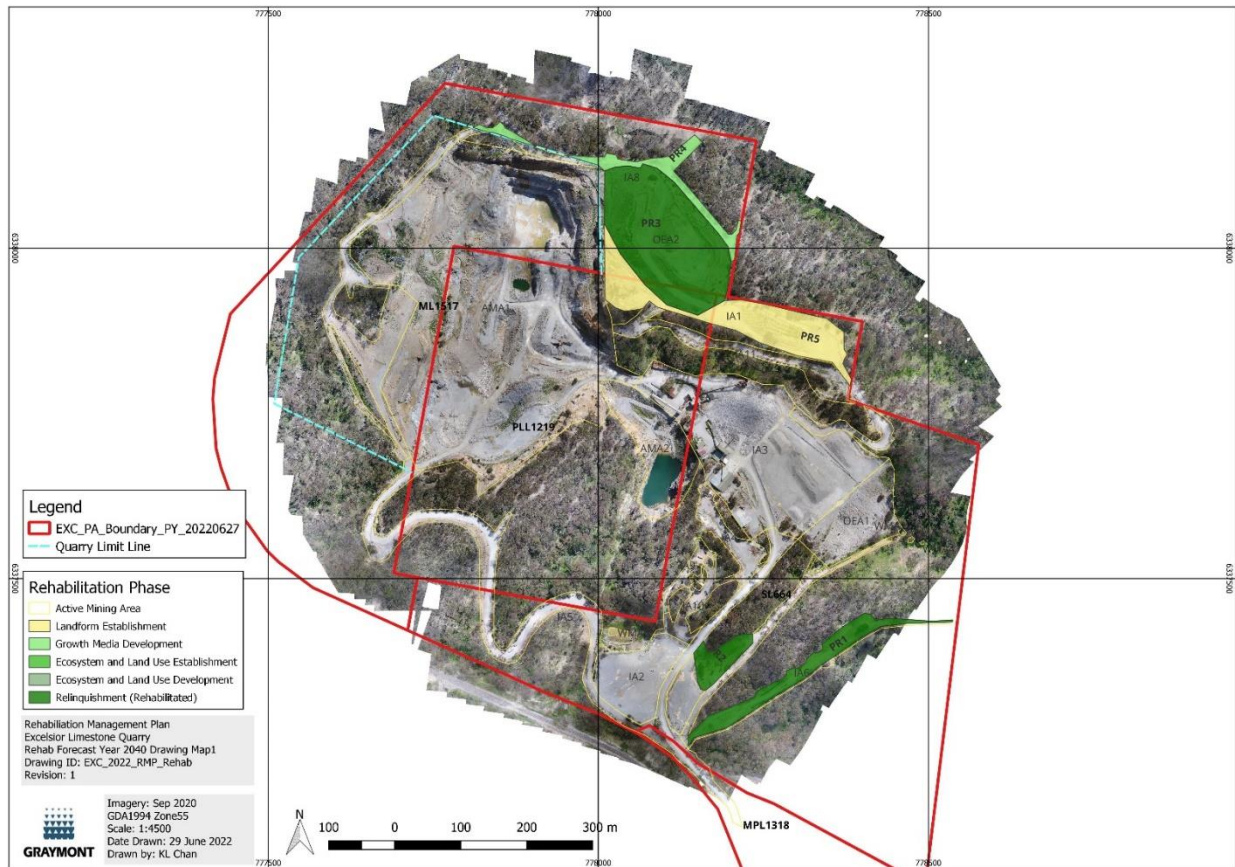
Figure 11: Rehabilitation by the end of 2040

The infrastructure area IA8, a gravel road, is intended to begin the landform establishment phase in 2039 and then progress to growth media development in 2040. A topsoil stockpile area IA1 will commence the landform establishment phase in 2040.

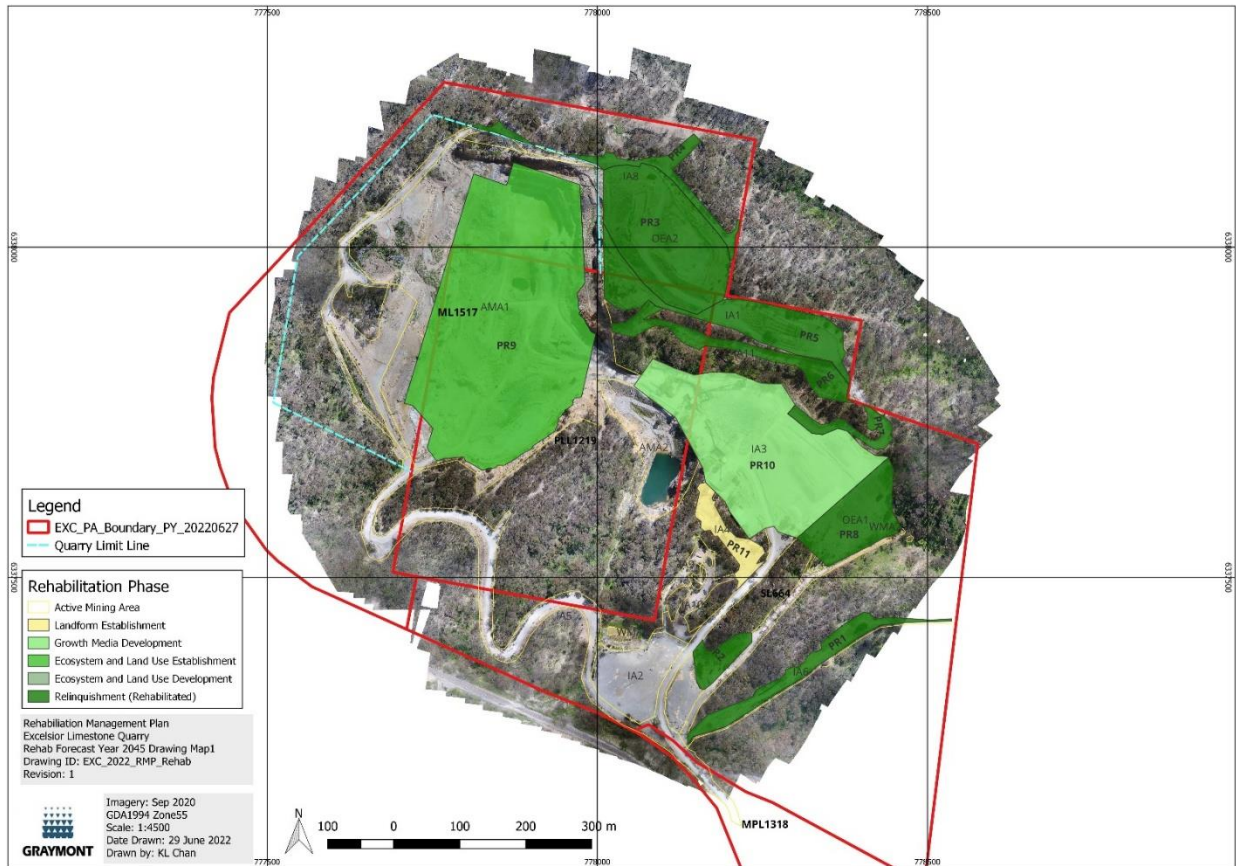
Figure 12: Rehabilitation by the end of 2045

IA8 will commence ecosystem and land use establishment and development phases in 2041, with the expectation that rehabilitation will be completed by 2042. IA1 will progress to growth media development in 2041, ecosystem and land use establishment in 2042, with rehabilitation completion estimated for 2043. IA11 and IA12 will move into growth media development in 2042 and ecosystem and land use establishment in 2043, with completion estimated for 2044. OEA1 will move into growth media development in 2043, ecosystem and land use establishment in 2044, with completion estimated for 2045.

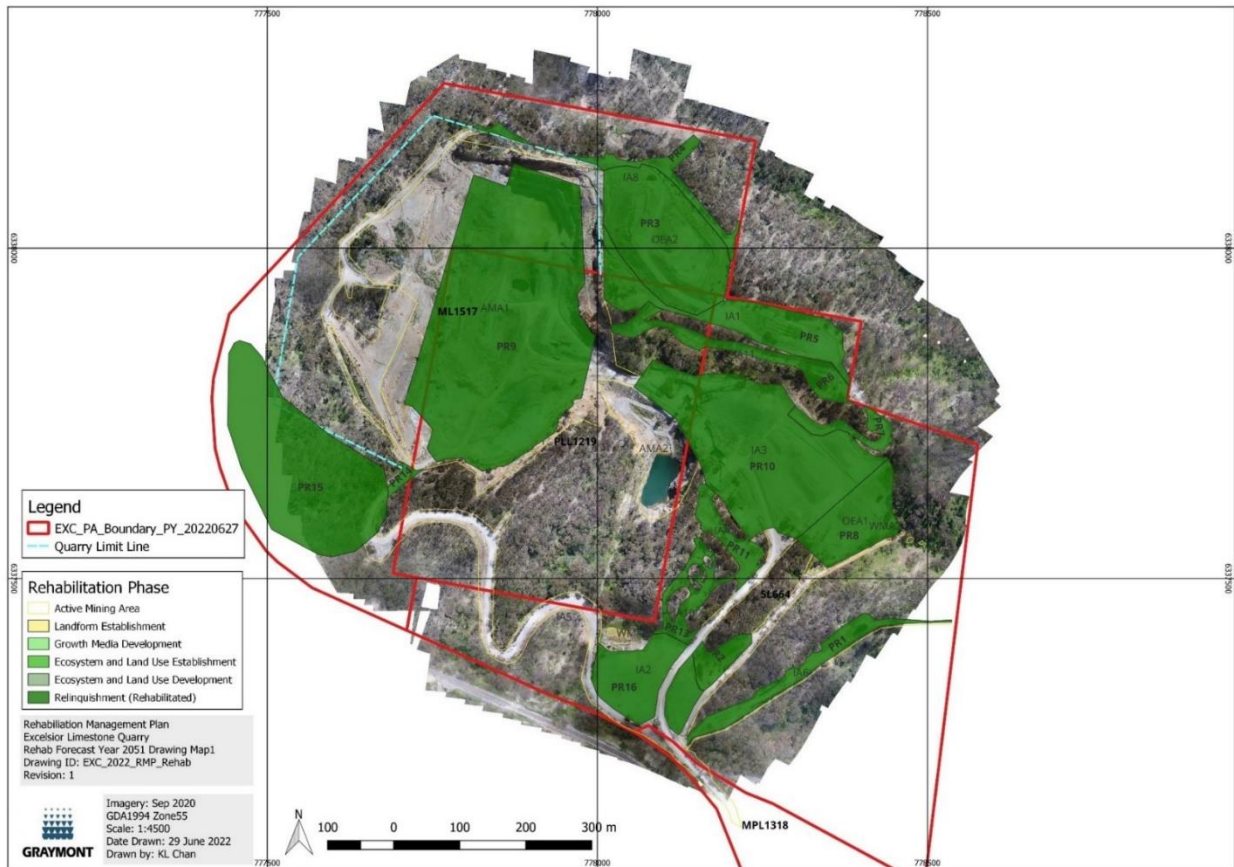
Figure 13: Rehabilitation by the end of 2051

It is intended to achieve rehabilitation completion for all the mining disturbed areas by 2051. During the 2046 to 2051 period, monitoring and maintenance activities will be undertaken to ensure rehabilitation success before mining closure.
