ARR0001102

ATTUNGA LIMESTONE MINE ANNUAL REHABILITATION REPORT

Saturday 4 June 2022 to Saturday 3 June 2023

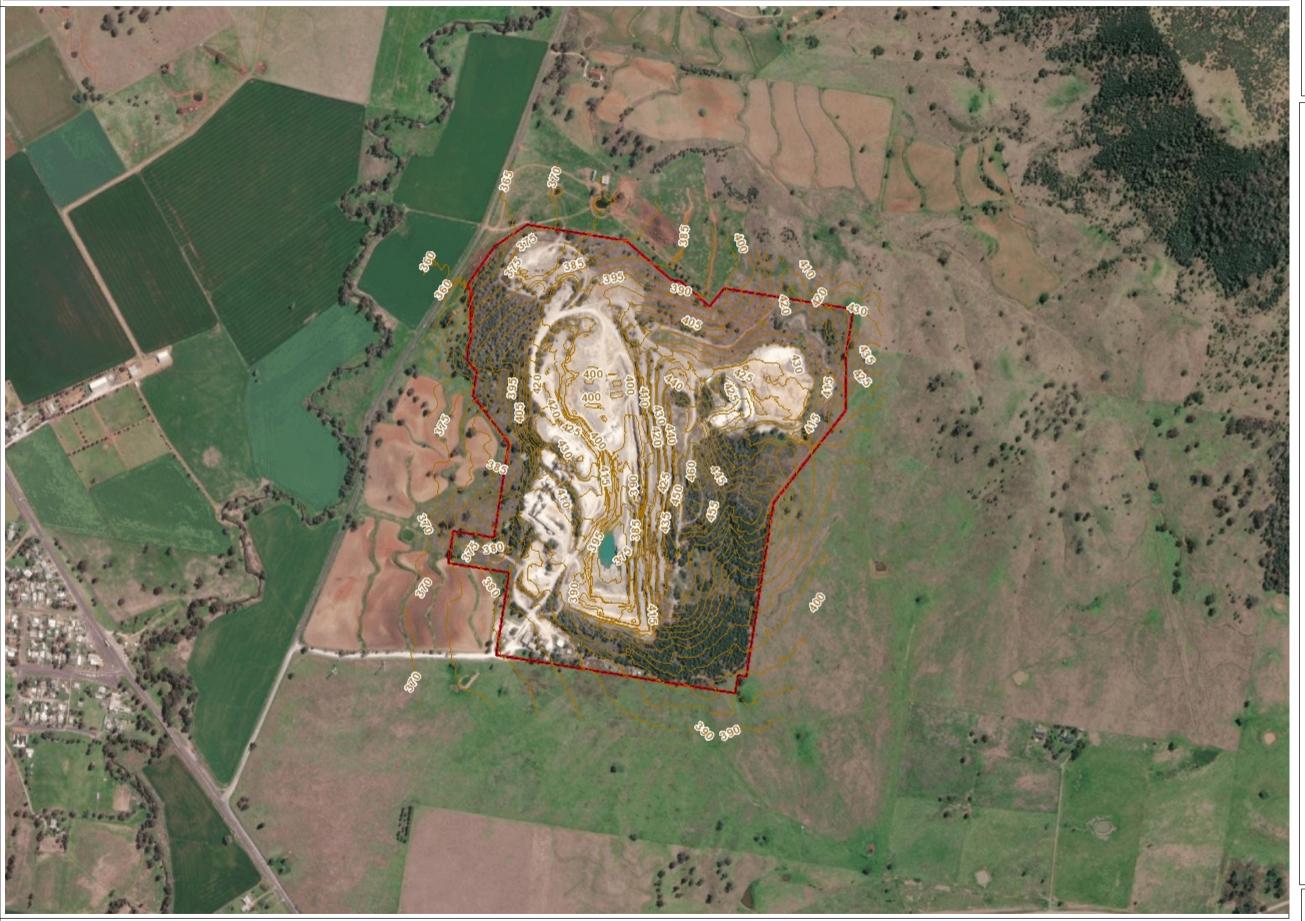
Attunga Limestone Mine - Plan 1B - Jun 2022 to Jun 2023 - Date 7/7/2023 - Sub No 5365

Current Landform Contours
 Project Approval Boundary
 World Imagery
 Low Resolution 15m Imagery
 High Resolution 60cm Imagery
