**GRAYMONT**

## Rehabilitation Management Plan (RMP)

Excelsior Limestone Mine

**8 August 2022**

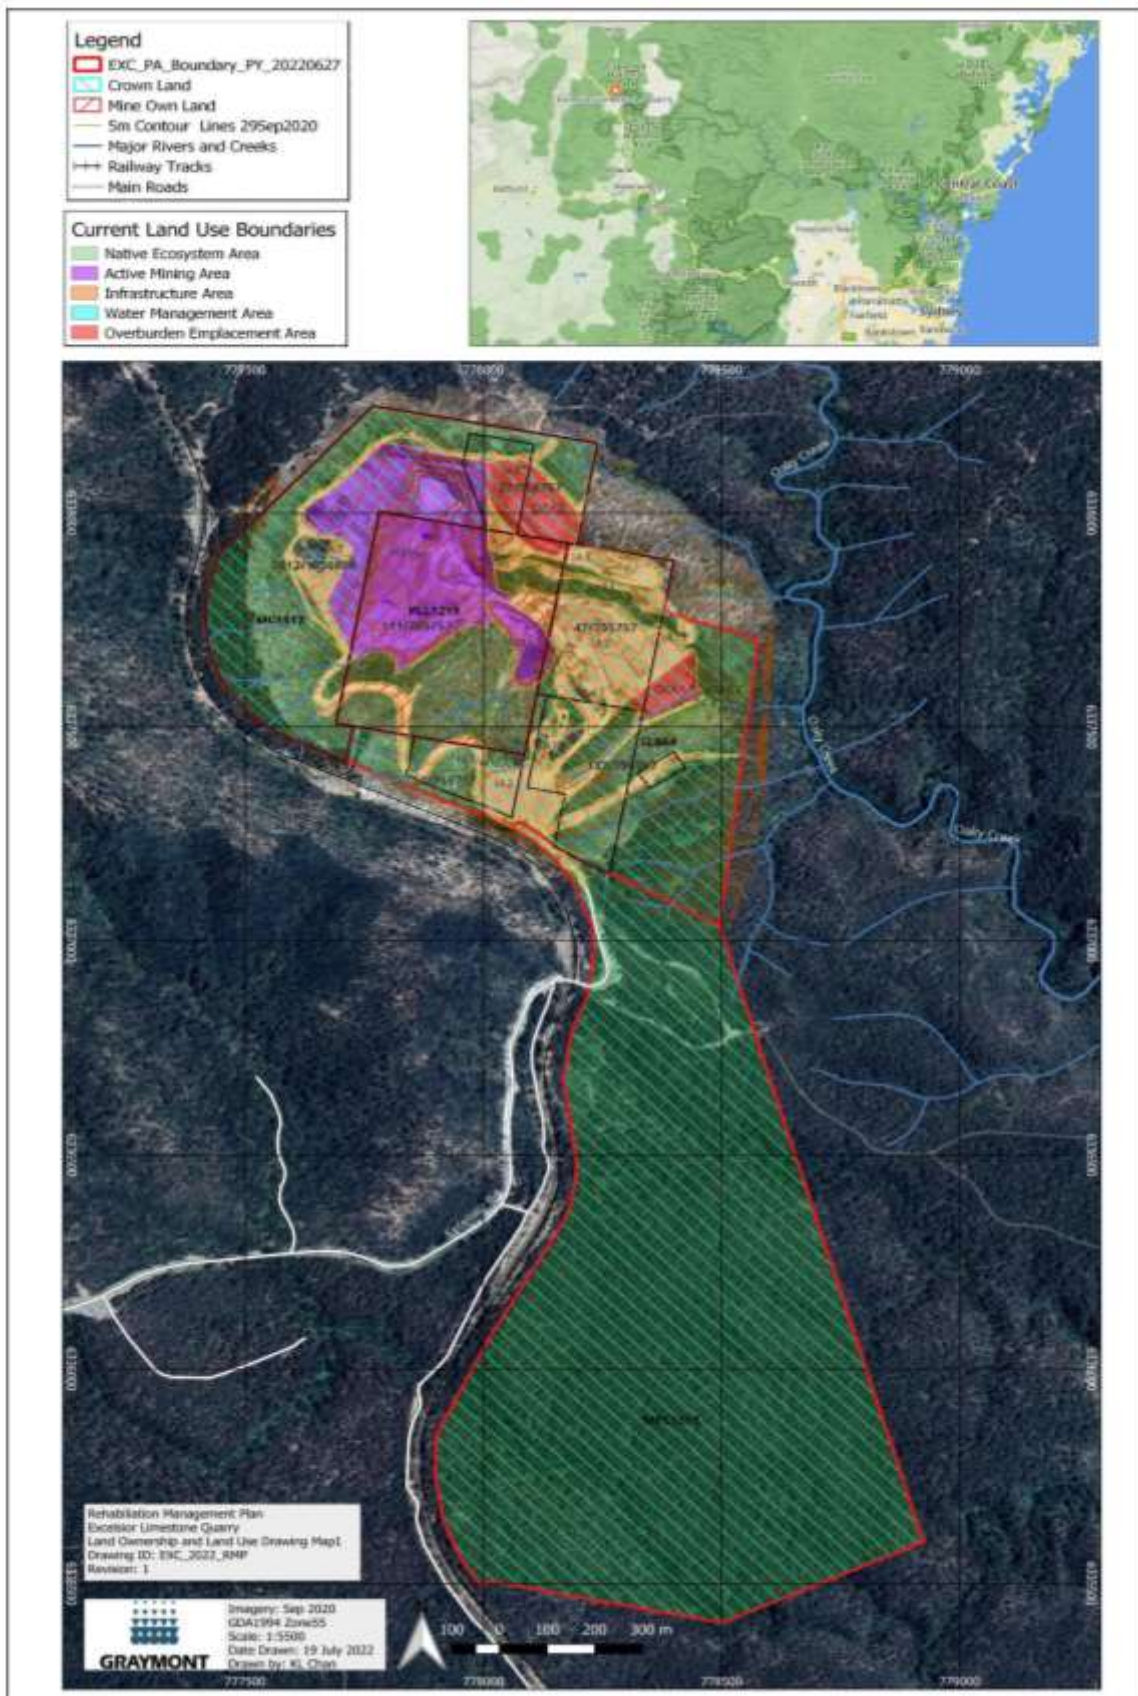
Figure 1: Land ownership and land use

Figure 1 describes the land ownership and land use in proximity to the mine site.

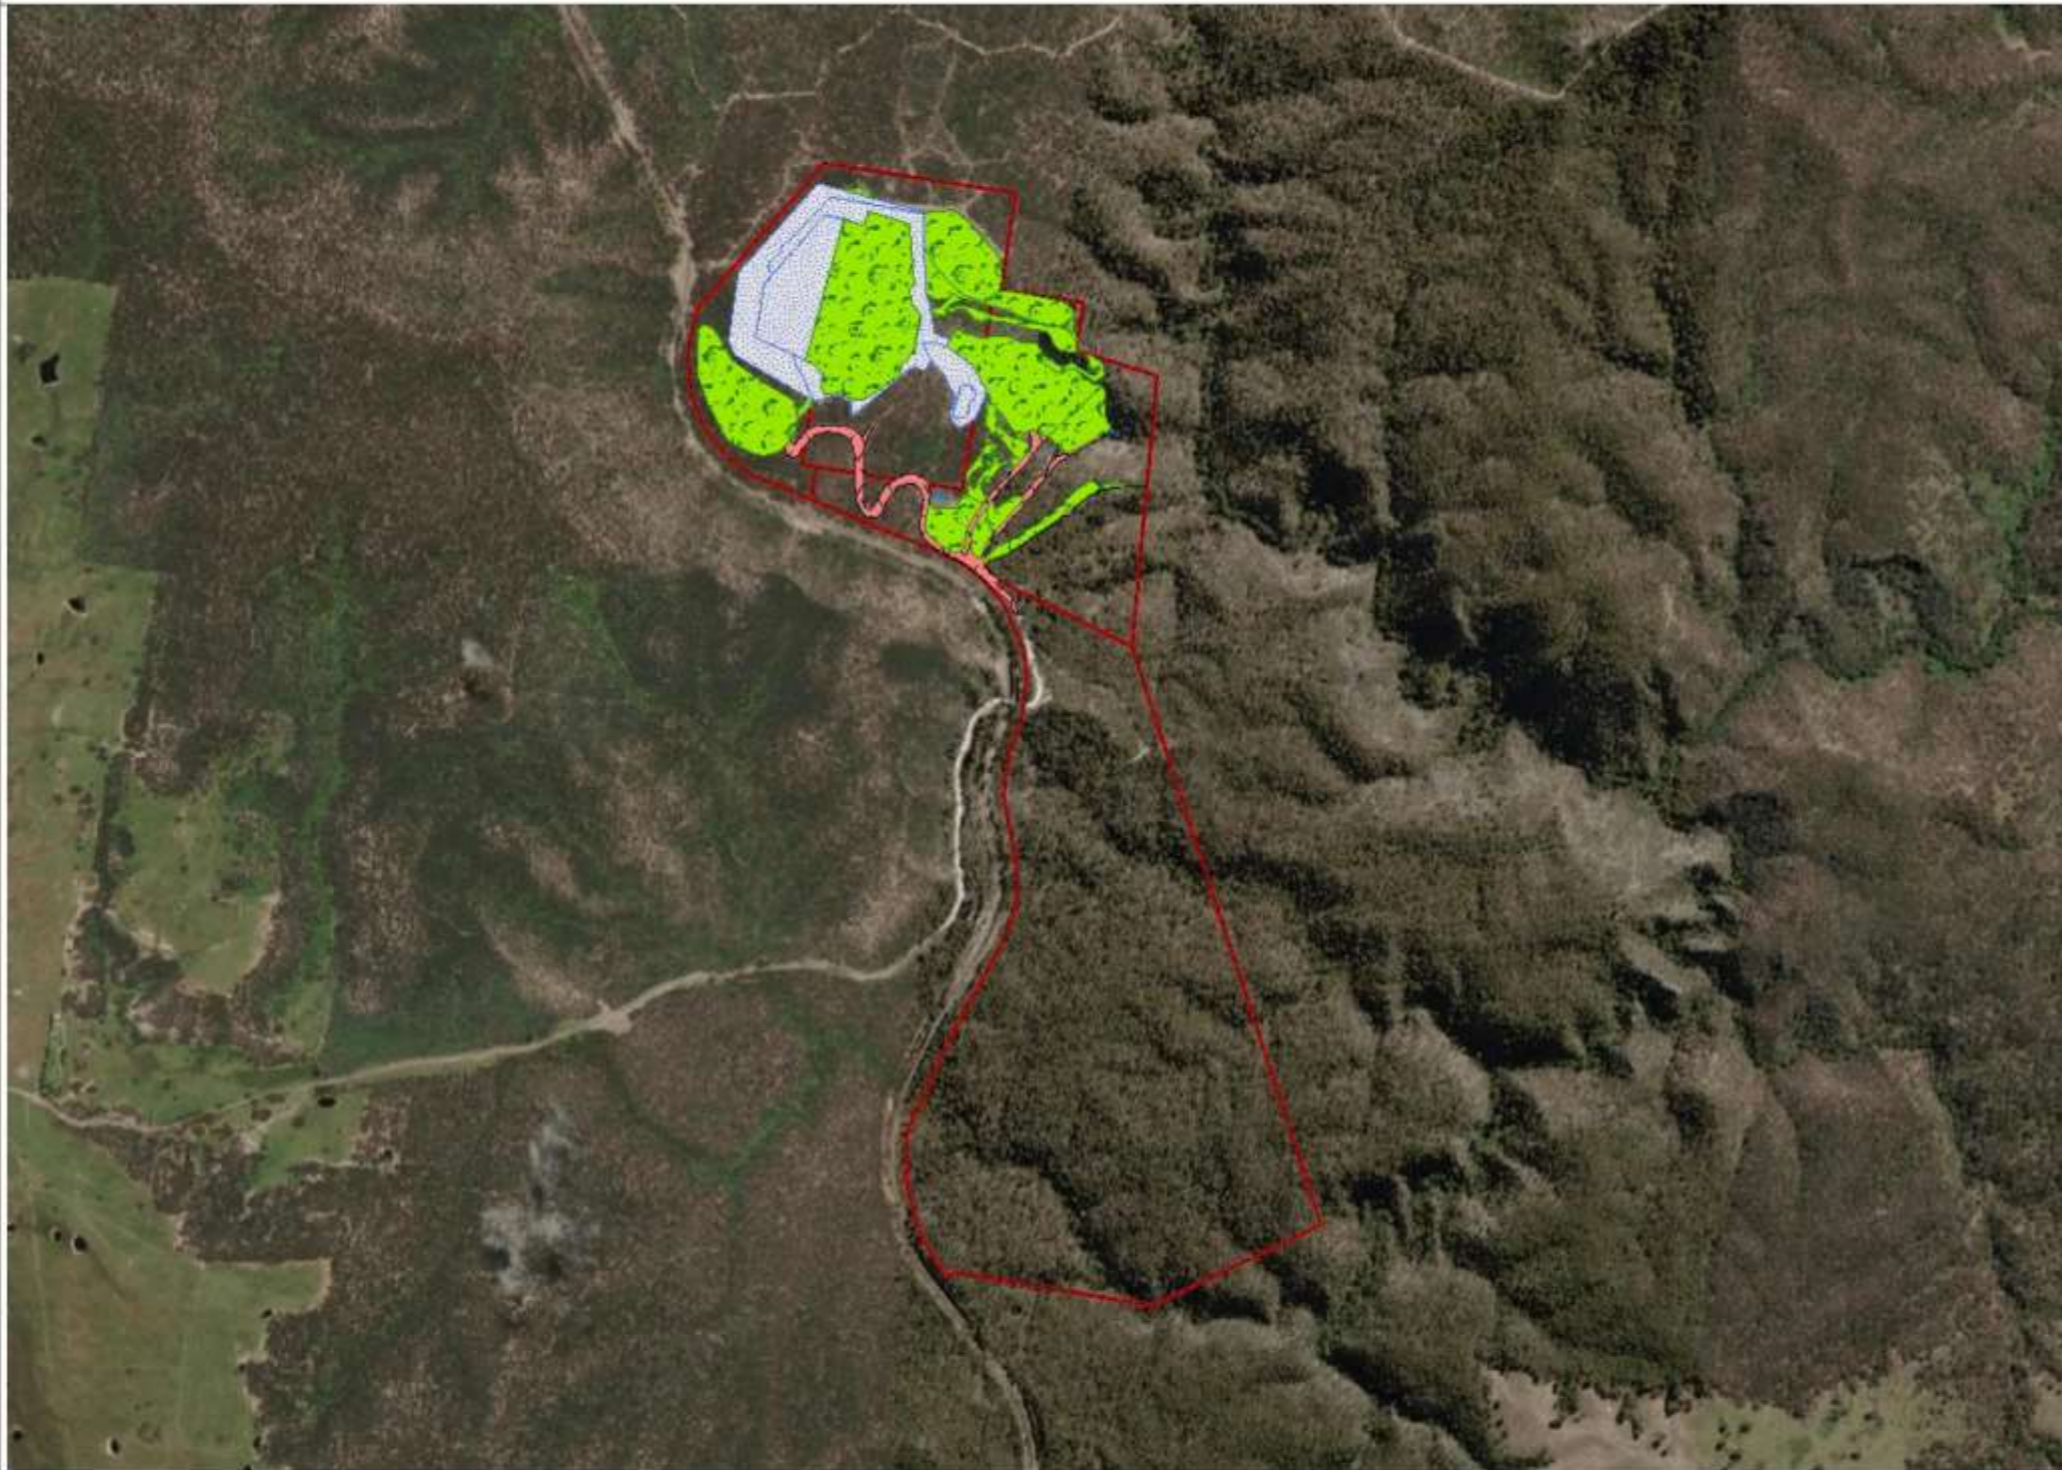
Figure 2 Final landform and rehabilitation plan - Final land use

The Figures 2 to 5 are an electronic copy of the final landform and rehabilitation plans submitted to the mine rehabilitation portal.

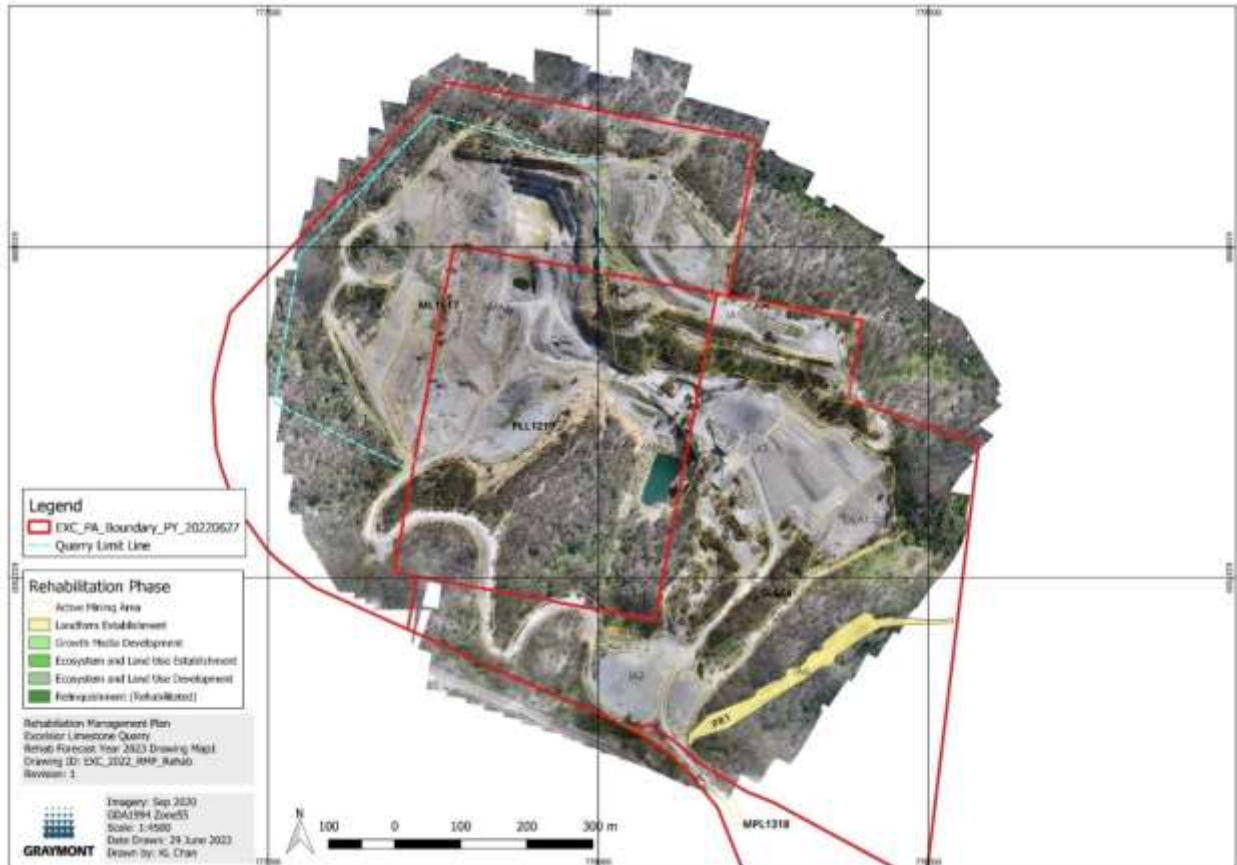
Figure 6: Rehabilitation by the end of 2023

The infrastructure area (IA6) will commence the landform establishment phase in 2023, refer to Figure 6. This area represents an internal road.

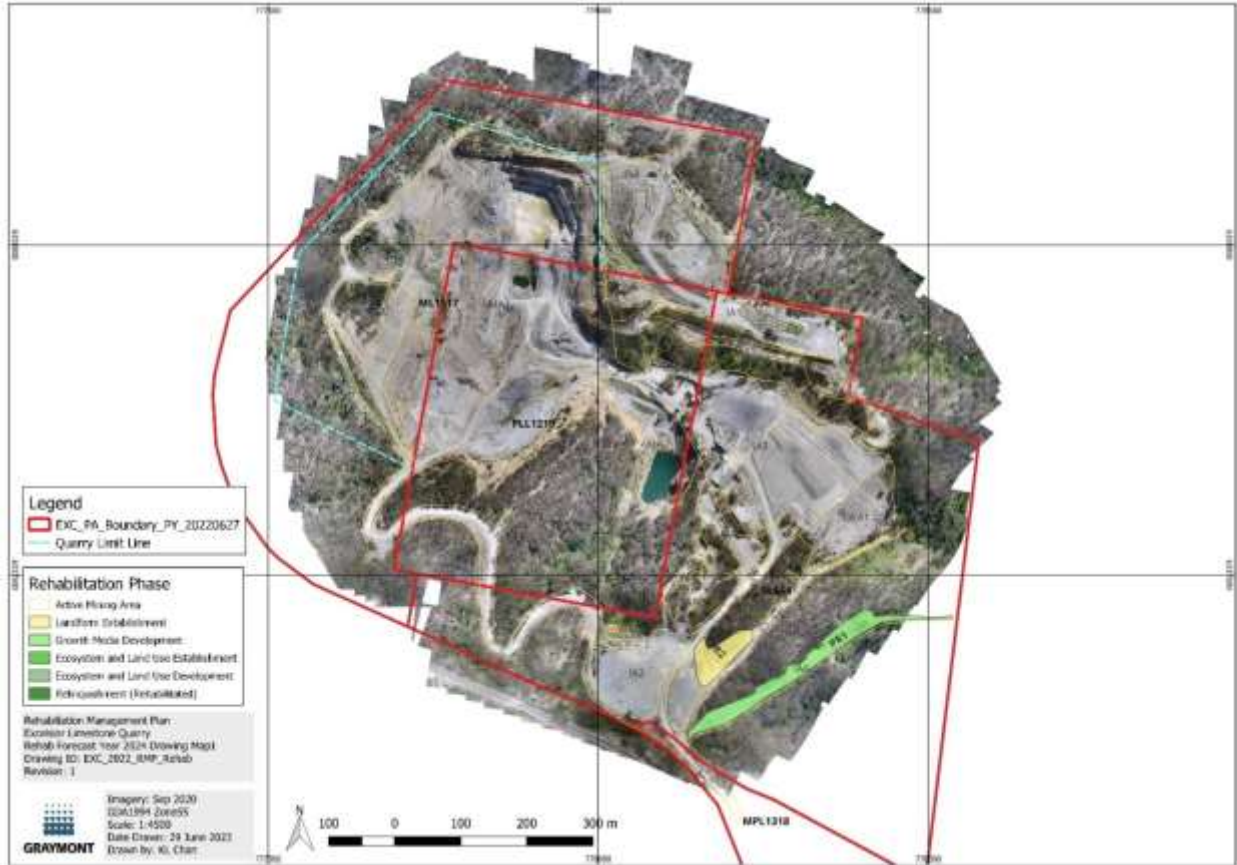
Figure 7: Rehabilitation by the end of 2024

The infrastructure area (IA6) will progress to the growth media development phase, while the infrastructure area (IA5) marked in the figure as R2 will commence the landform establishment phase.

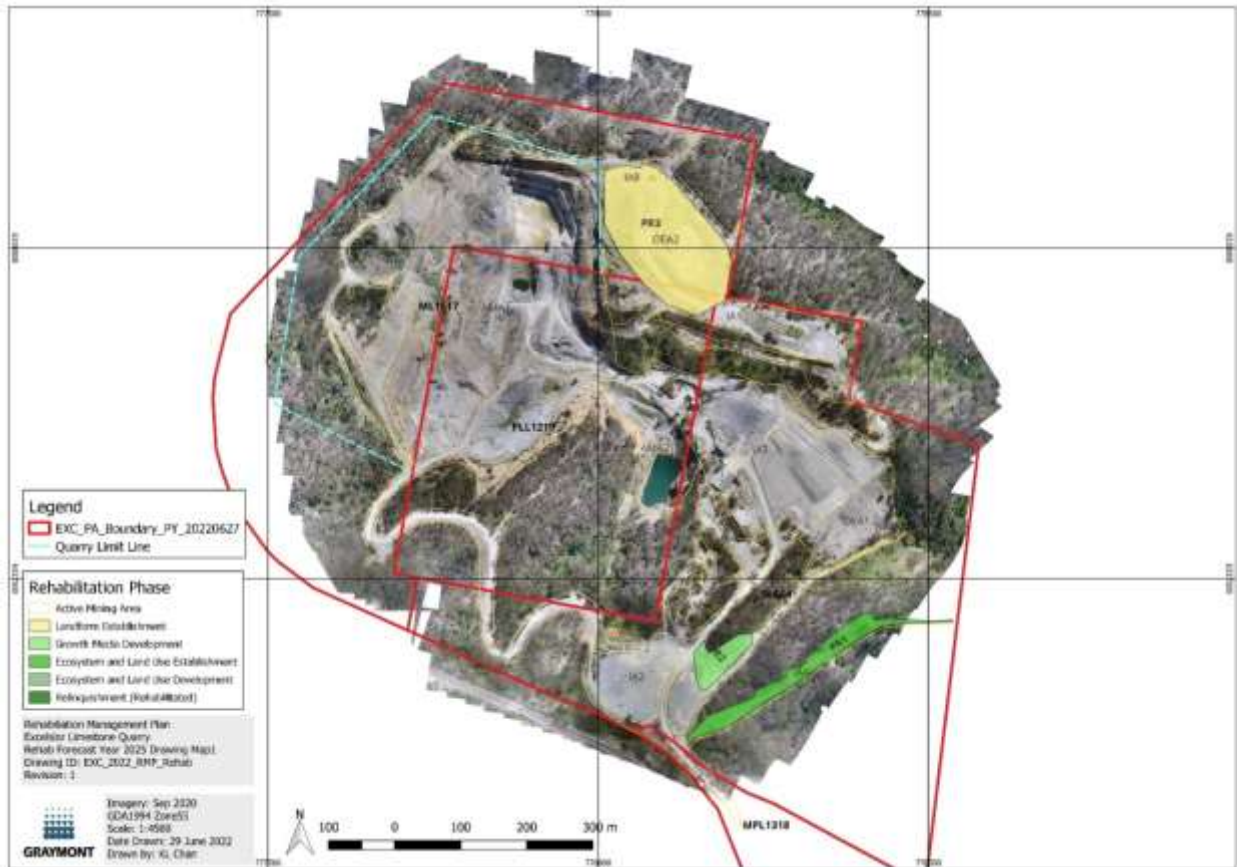
Figure 8: Rehabilitation by the end of 2025

IA6 is expected to proceed to the ecosystem and land use establishment phase by this year, while R2 is likely to move to growth media development. Overburden Emplacement Area (OEA2) will commence with the landform establishment phase and involves reshaping of the existing overburden emplacement.

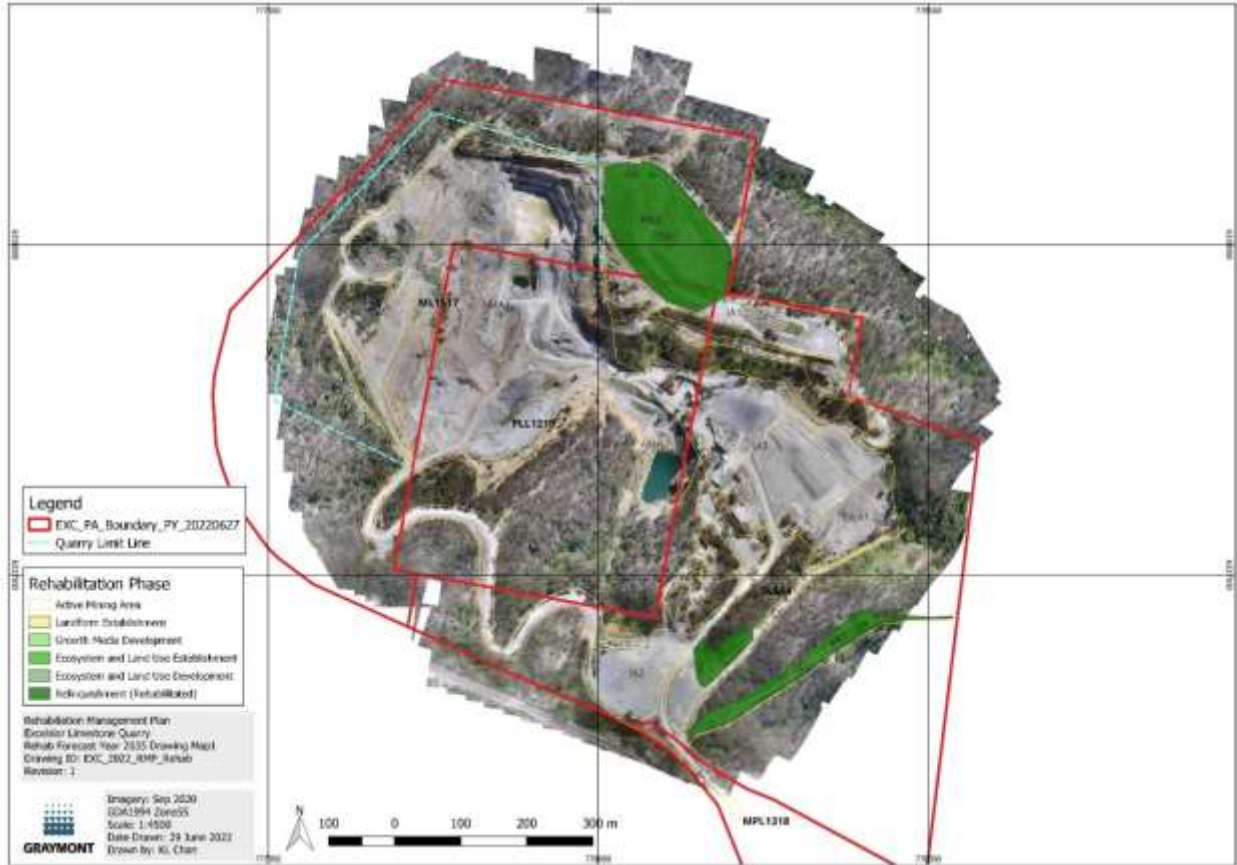
Figure 10: Rehabilitation by the end of 2035

No further rehabilitation occurs during this time. However, rehabilitation monitoring and maintenance work will continue during this time as per Chapter 8 of this document.

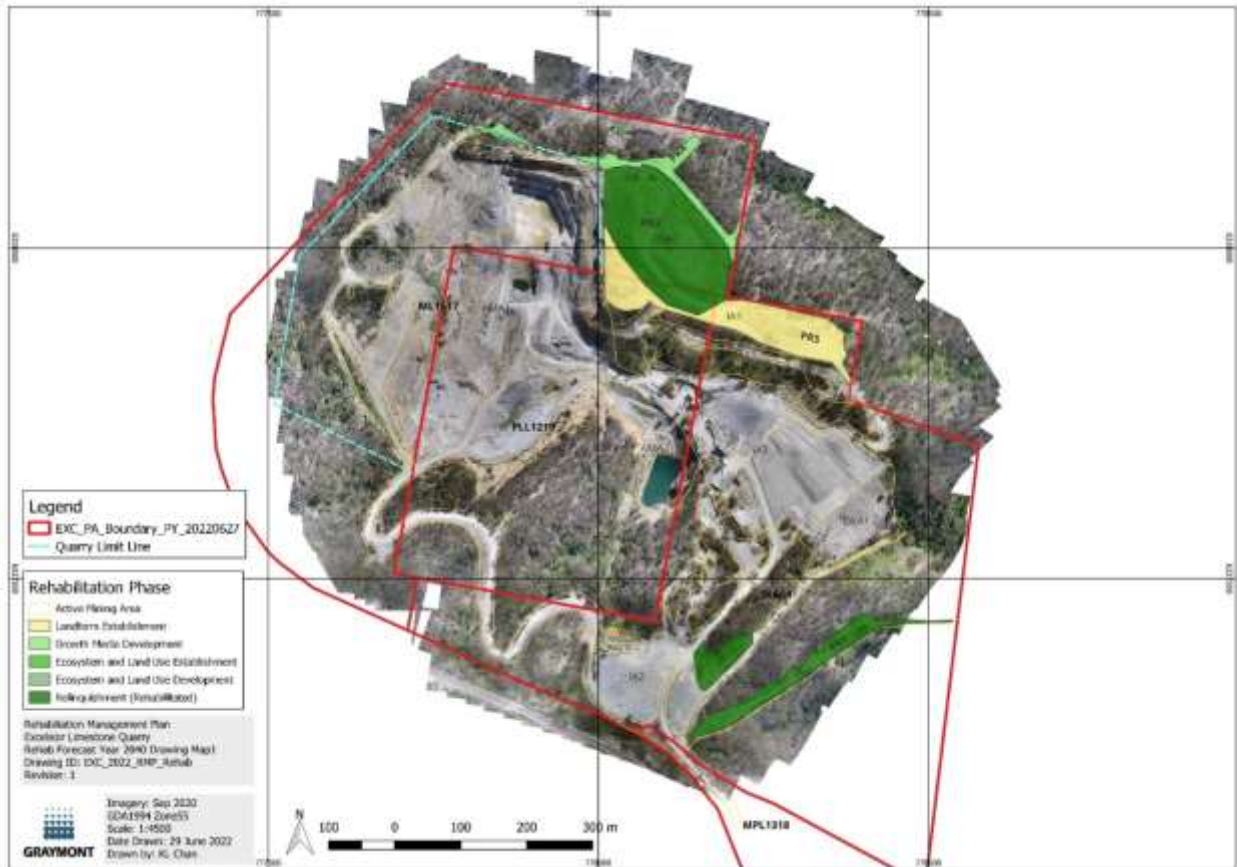
Figure 11: Rehabilitation by the end of 2040

The infrastructure area IA8, a gravel road, is intended to begin the landform establishment phase in 2039 and then progress to growth media development in 2040. A topsoil stockpile area IA1 will commence the landform establishment phase in 2040.

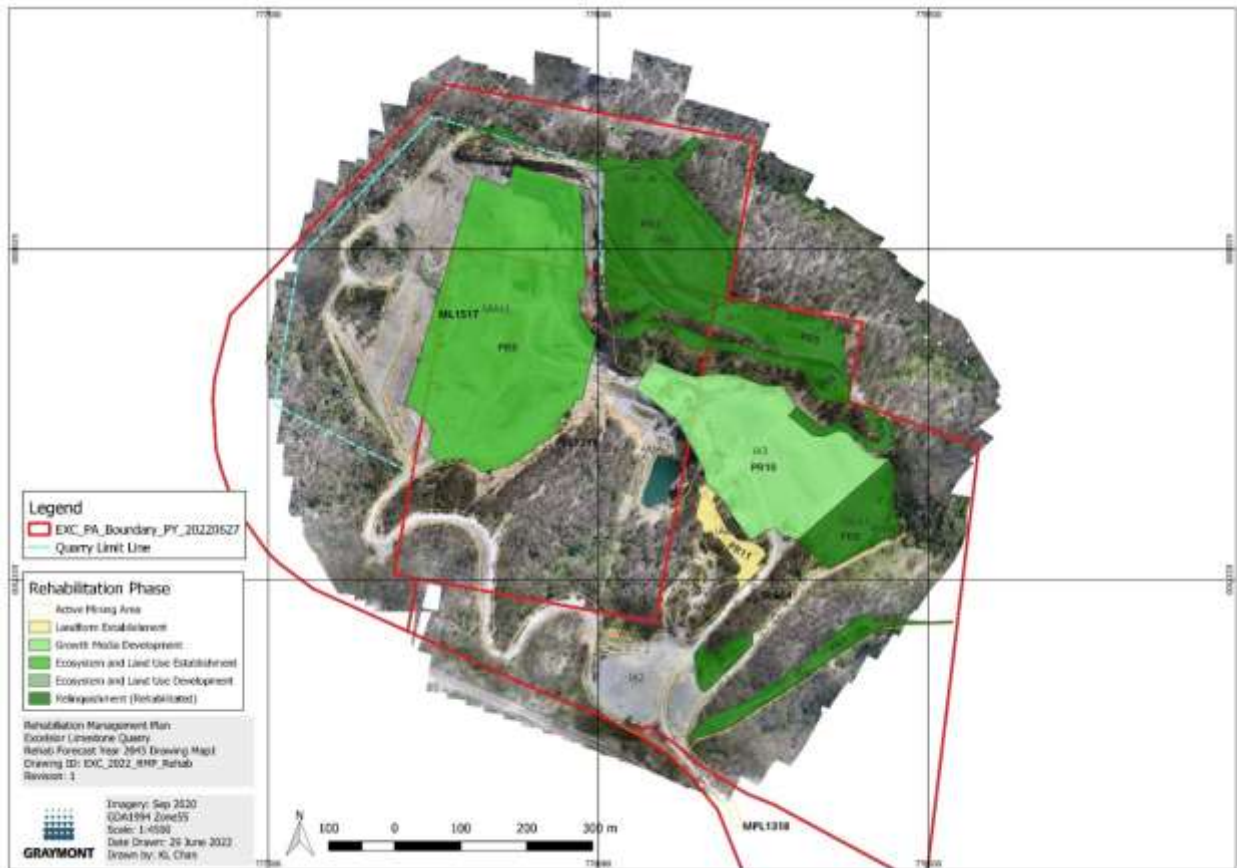
Figure 12: Rehabilitation by the end of 2045

IA8 will commence ecosystem and land use establishment and development phases in 2041, with the expectation that rehabilitation will be completed by 2042. IA1 will progress to growth media development in 2041, ecosystem and land use establishment in 2042, with rehabilitation completion estimated for 2043. IA11 and IA12 will move into growth media development in 2042 and ecosystem and land use establishment in 2043, with completion estimated for 2044. OEA1 will move into growth media development in 2043, ecosystem and land use establishment in 2044, with completion estimated for 2045.

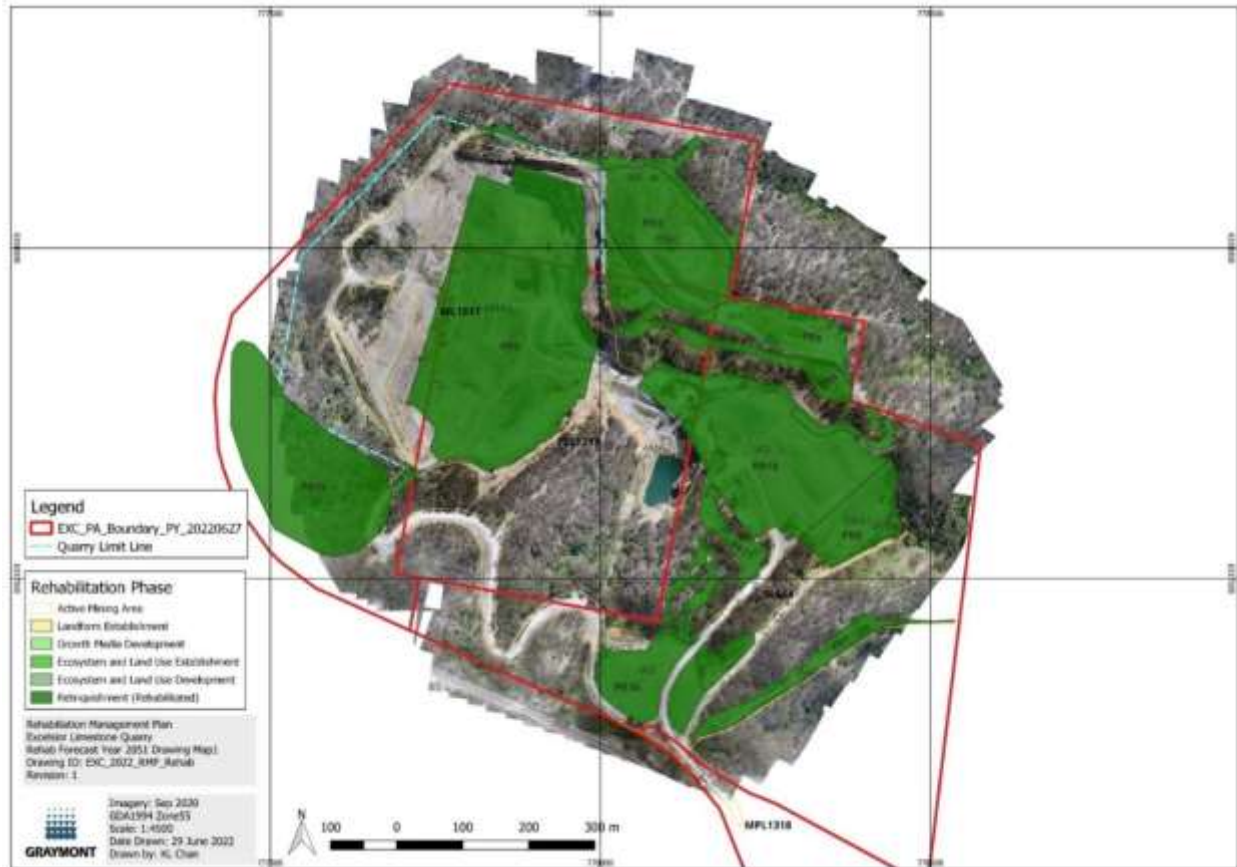
Figure 13: Rehabilitation by the end of 2051

It is intended to achieve rehabilitation completion for all the mining disturbed areas by 2051. During the 2046 to 2051 period, monitoring and maintenance activities will be undertaken to ensure rehabilitation success before mining closure.
