Rehabilitation Management Plan (RMP)

Excelsior Limestone Mine

Date **2 June 2023**

Rev01

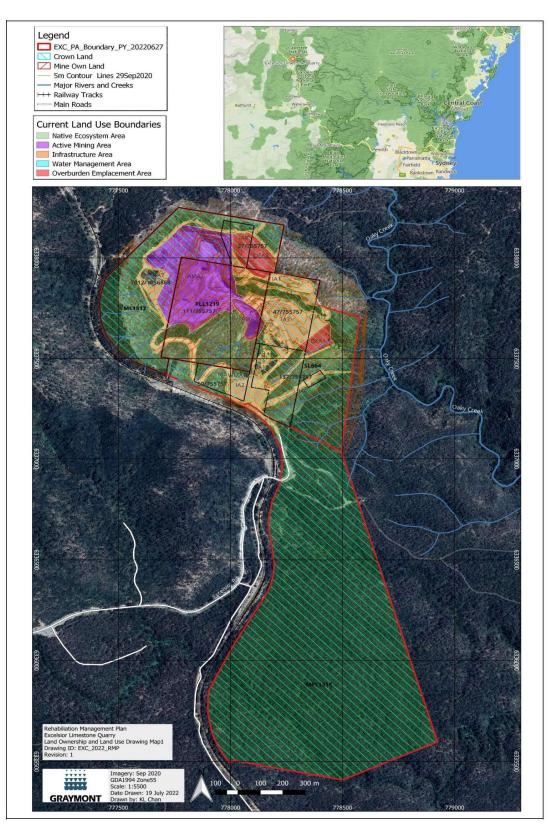
Figure 1 describes the land ownership and land use in proximity to the mine site.

Figure 1: Land ownership and land use

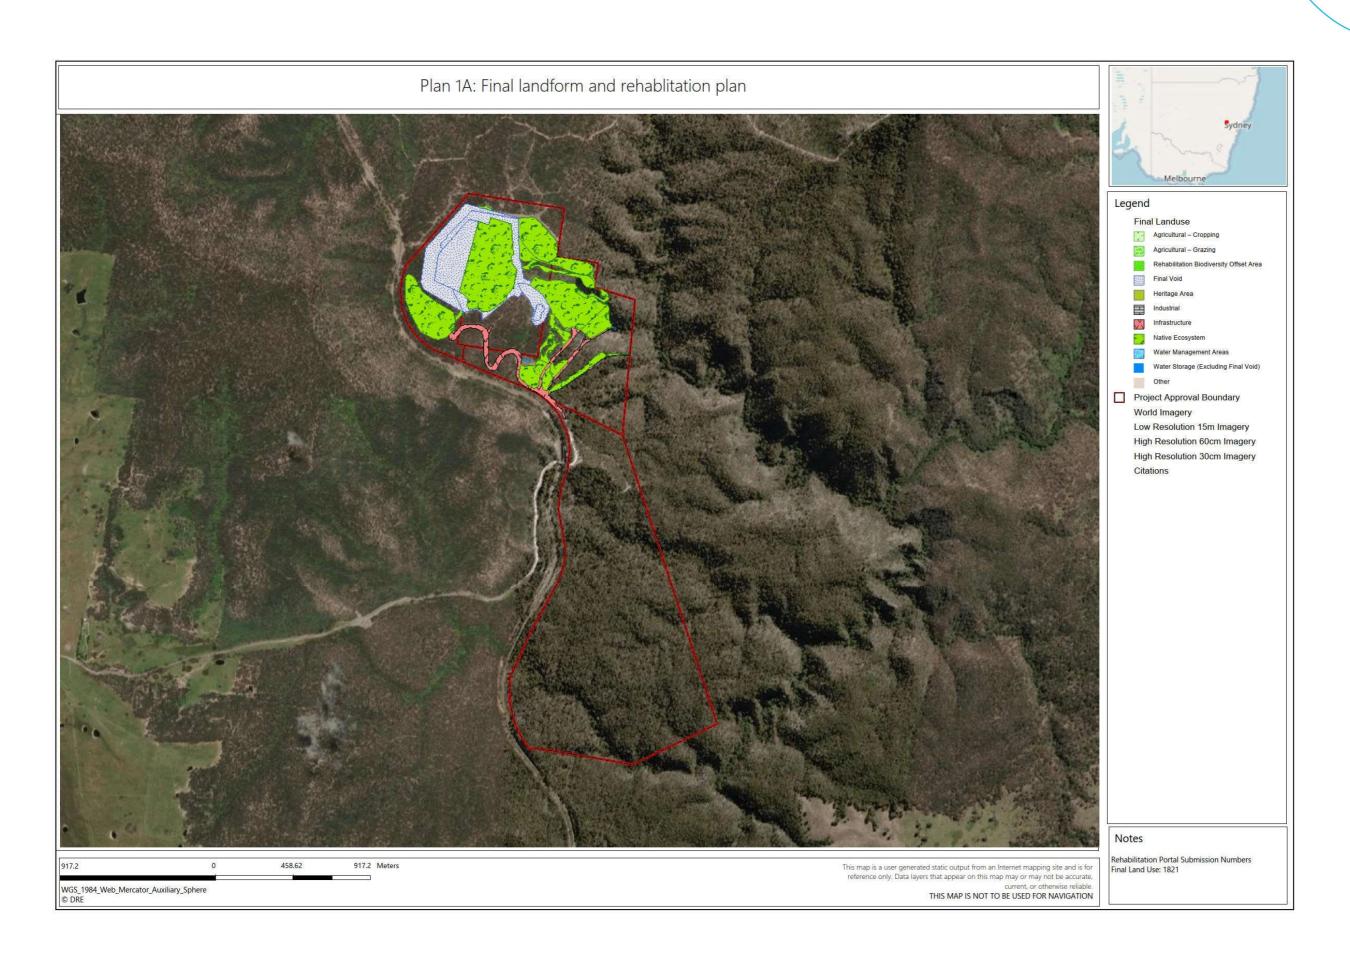
Figure 2 Final landform and rehabilitation plan - Final land use

The Figures 2 to 5 are an electronic copy of the final landform and rehabilitation plans submitted to the mine rehabilitation portal.

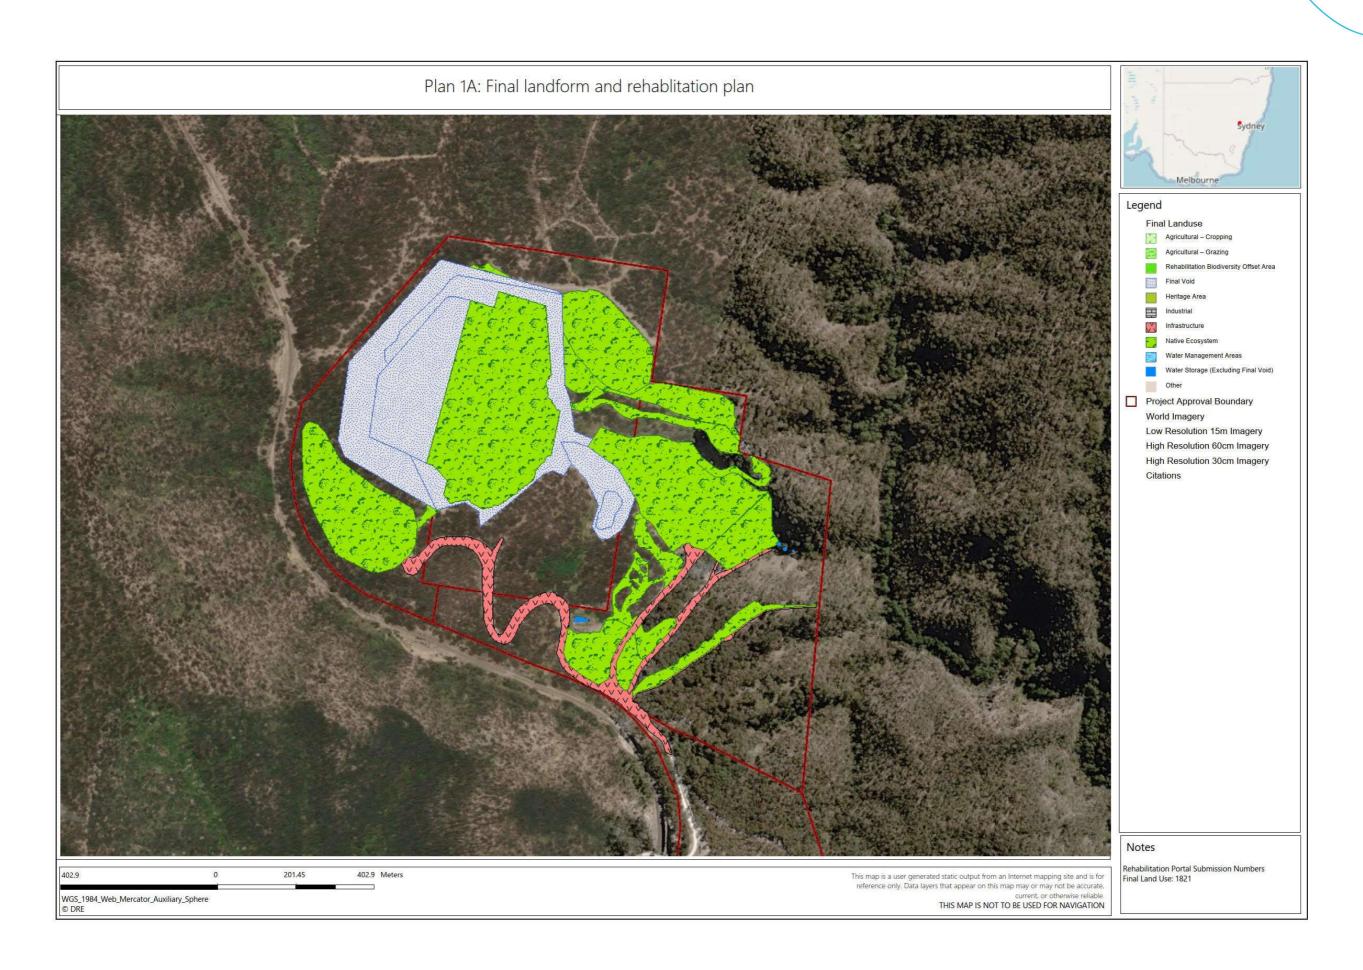
Figure 3 Final landform and rehabilitation plan - Final land use (Large scale)

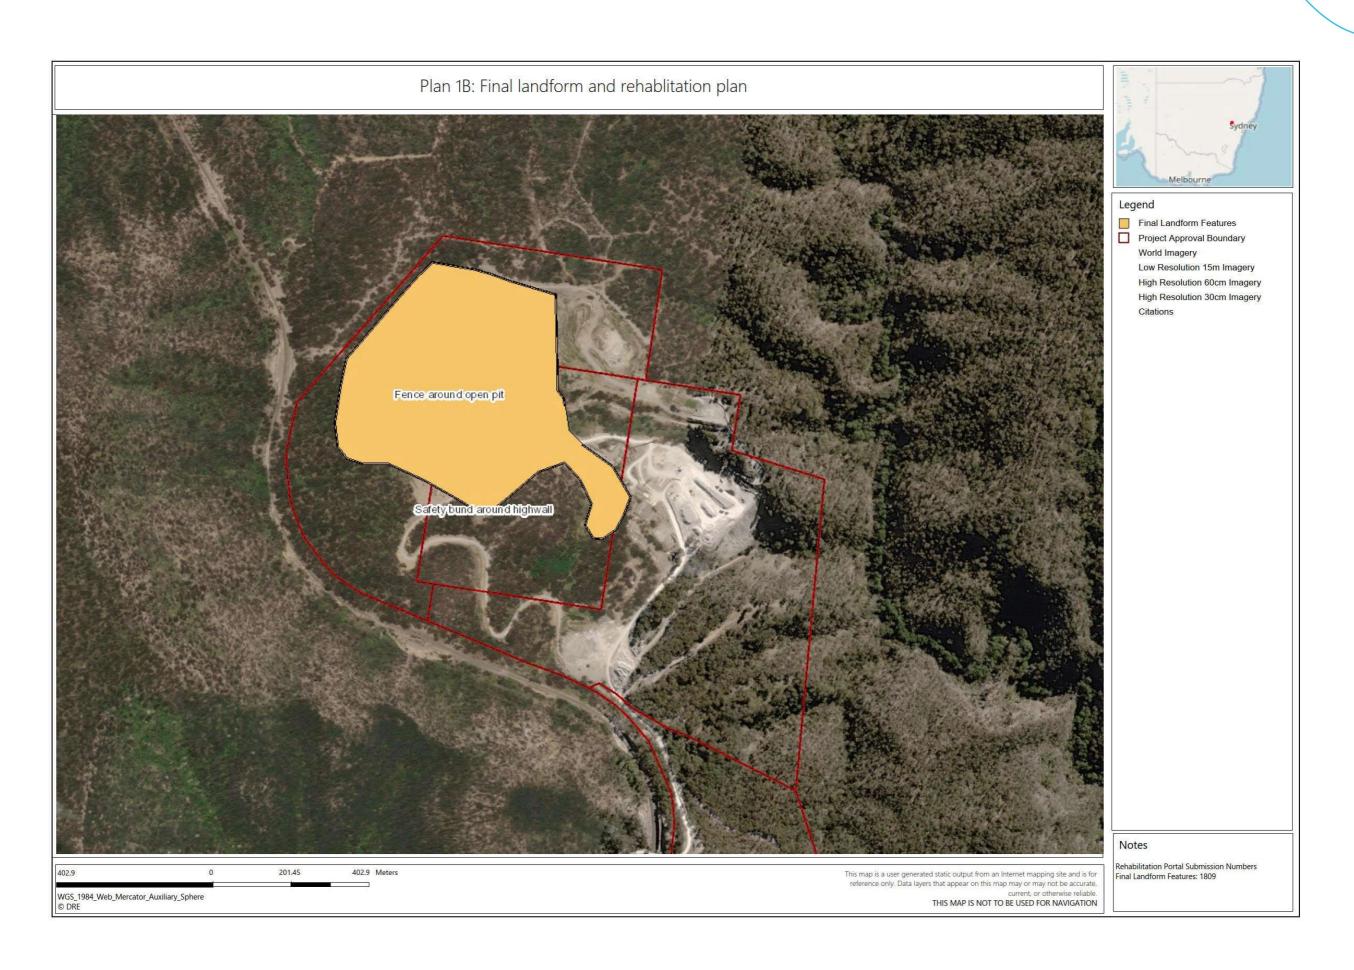
Figure 4 Final landform and rehabilitation plan - Final landform features (Large scale)

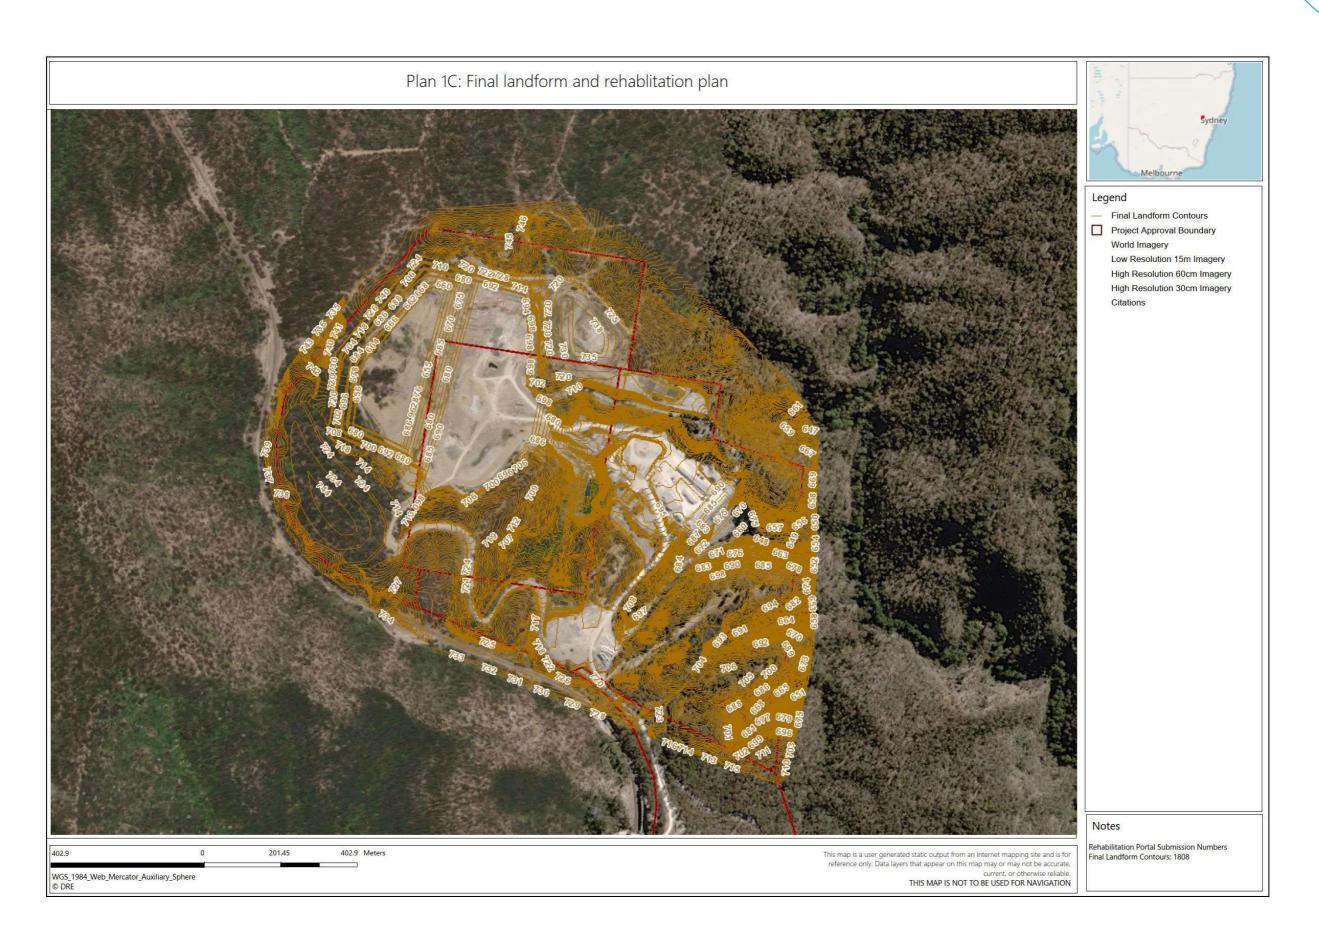
Figure 5 Final landform and rehabilitation plan - Final landform contours (Large scale)

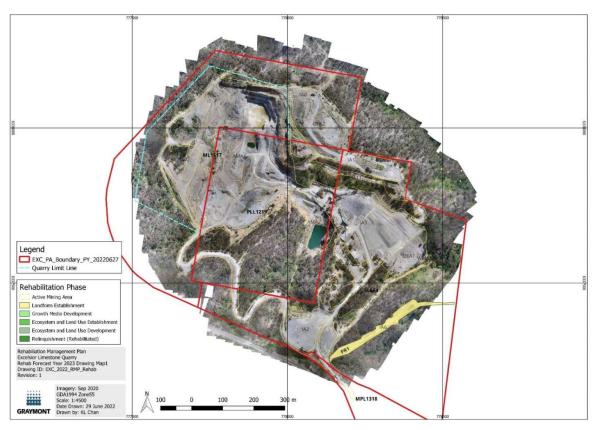
The infrastructure area (IA6) will commence the landform establishment phase in 2023, refer to Figure 6. This area represents an internal road.

Figure 6: Rehabilitation by the end of 2023

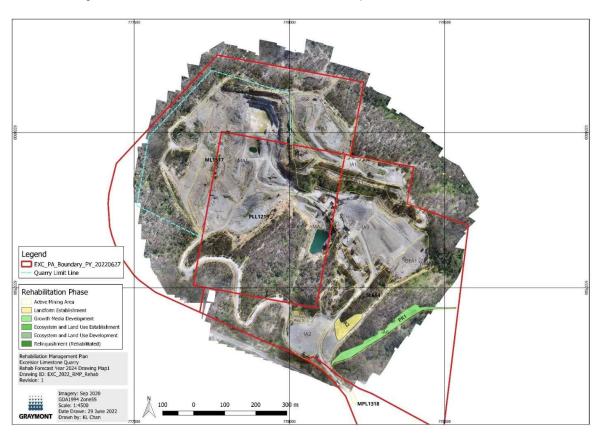
The infrastructure area (IA6) will progress to the growth media development phase, while the infrastructure area (IA5) marked in the figure as R2 will commence the landform establishment phase.

Figure 7: Rehabilitation by the end of 2024

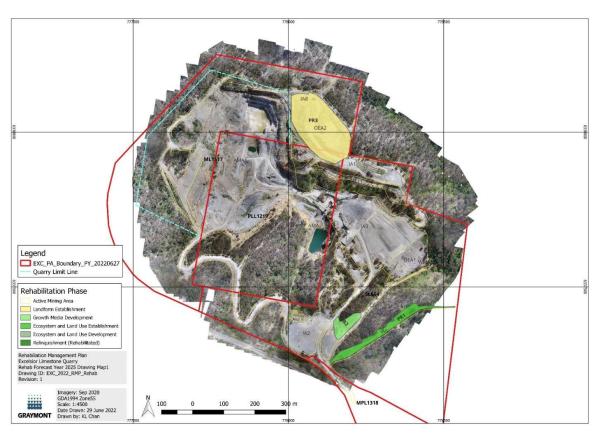
IA6 is expected to proceed to the ecosystem and land use establishment phase by this year, while R2 is likely to move to growth media development. Overburden Emplacement Area (OEA2) will commence with the landform establishment phase and involves reshaping of the existing overburden emplacement.

Figure 8: Rehabilitation by the end of 2025

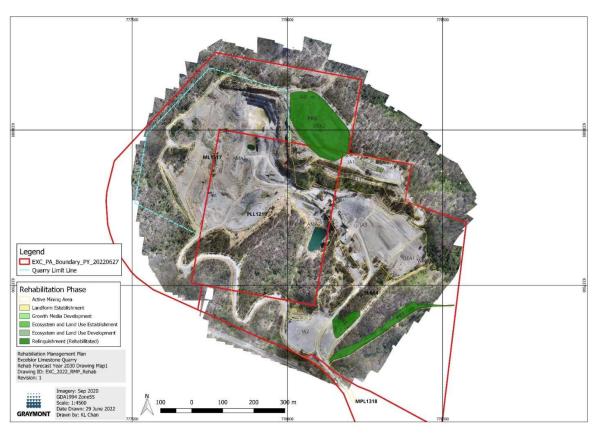
IA6 is expected to achieve rehabilitation completion by 2026. R2 is scheduled to enter the ecosystem and land use establishment phase in 2026 and be completed by 2027. OEA2 is intended to begin the growth media development phase by 2026, progress to the ecosystem and land use establishment and development in 2027 and achieve rehabilitation completion by 2028.

Figure 9: Rehabilitation by the end of 2030

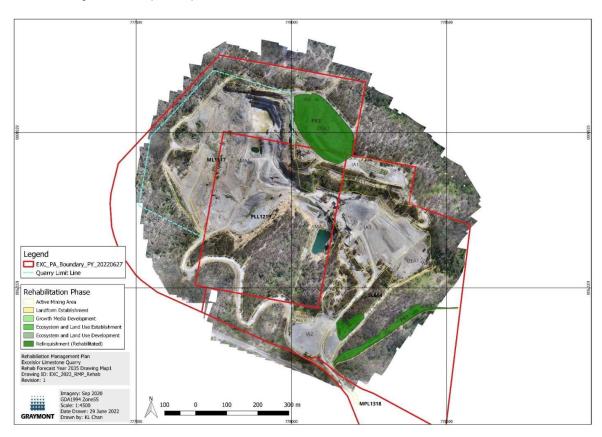
No further rehabilitation occurs during this time. However, rehabilitation monitoring and maintenance work will continue during this time as per Chapter 8 of this document.

Figure 10: Rehabilitation by the end of 2035

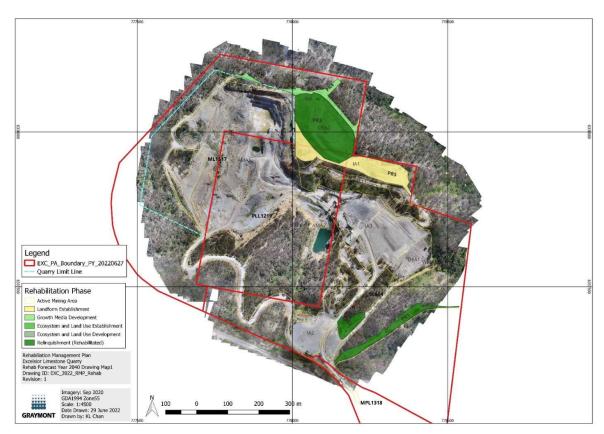
The infrastructure area IA8, a gravel road, is intended to begin the landform establishment phase in 2039 and then progress to growth media development in 2040. A topsoil stockpile area IA1 will commence the landform establishment phase in 2040.

Figure 11: Rehabilitation by the end of 2040

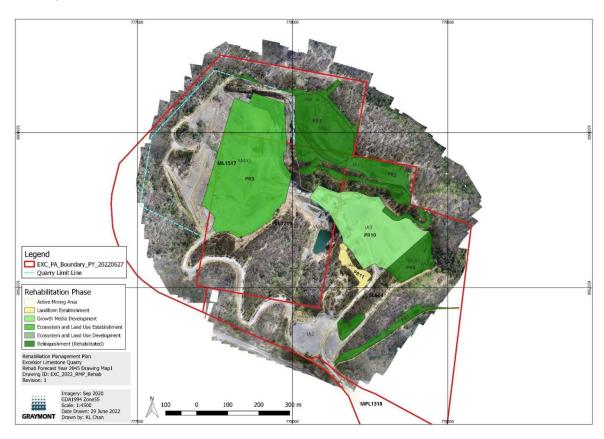
IA8 will commence ecosystem and land use establishment and development phases in 2041, with the expectation that rehabilitation will be completed by 2042. IA1 will progress to growth media development in 2041, ecosystem and land use establishment in 2042, with rehabilitation completion estimated for 2043. IA11 and IA12 will move into growth media development in 2042 and ecosystem and land use establishment in 2043, with completion estimated for 2044. OEA1 will move into growth media development in 2043, ecosystem and land use establishment in 2044, with completion estimated for 2045.

Figure 12: Rehabilitation by the end of 2045

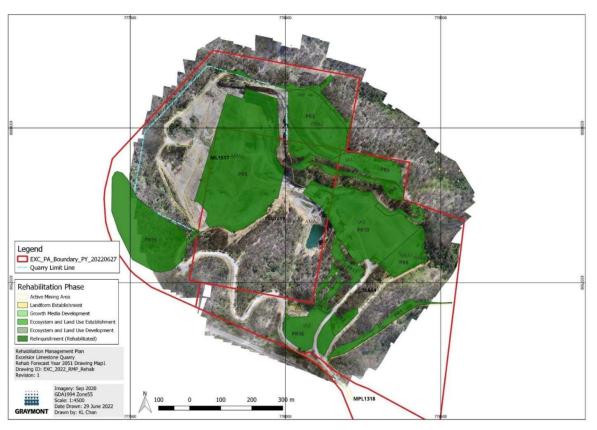
It is intended to achieve rehabilitation completion for all the mining disturbed areas by 2051. During the 2046 to 2051 period, monitoring and maintenance activities will be undertaken to ensure rehabilitation success before mining closure.

Figure 13: Rehabilitation by the end of 2051
