Rehabilitation Management Plan (RMP)

Sulcor Limestone Mine

Date
8 August 2022

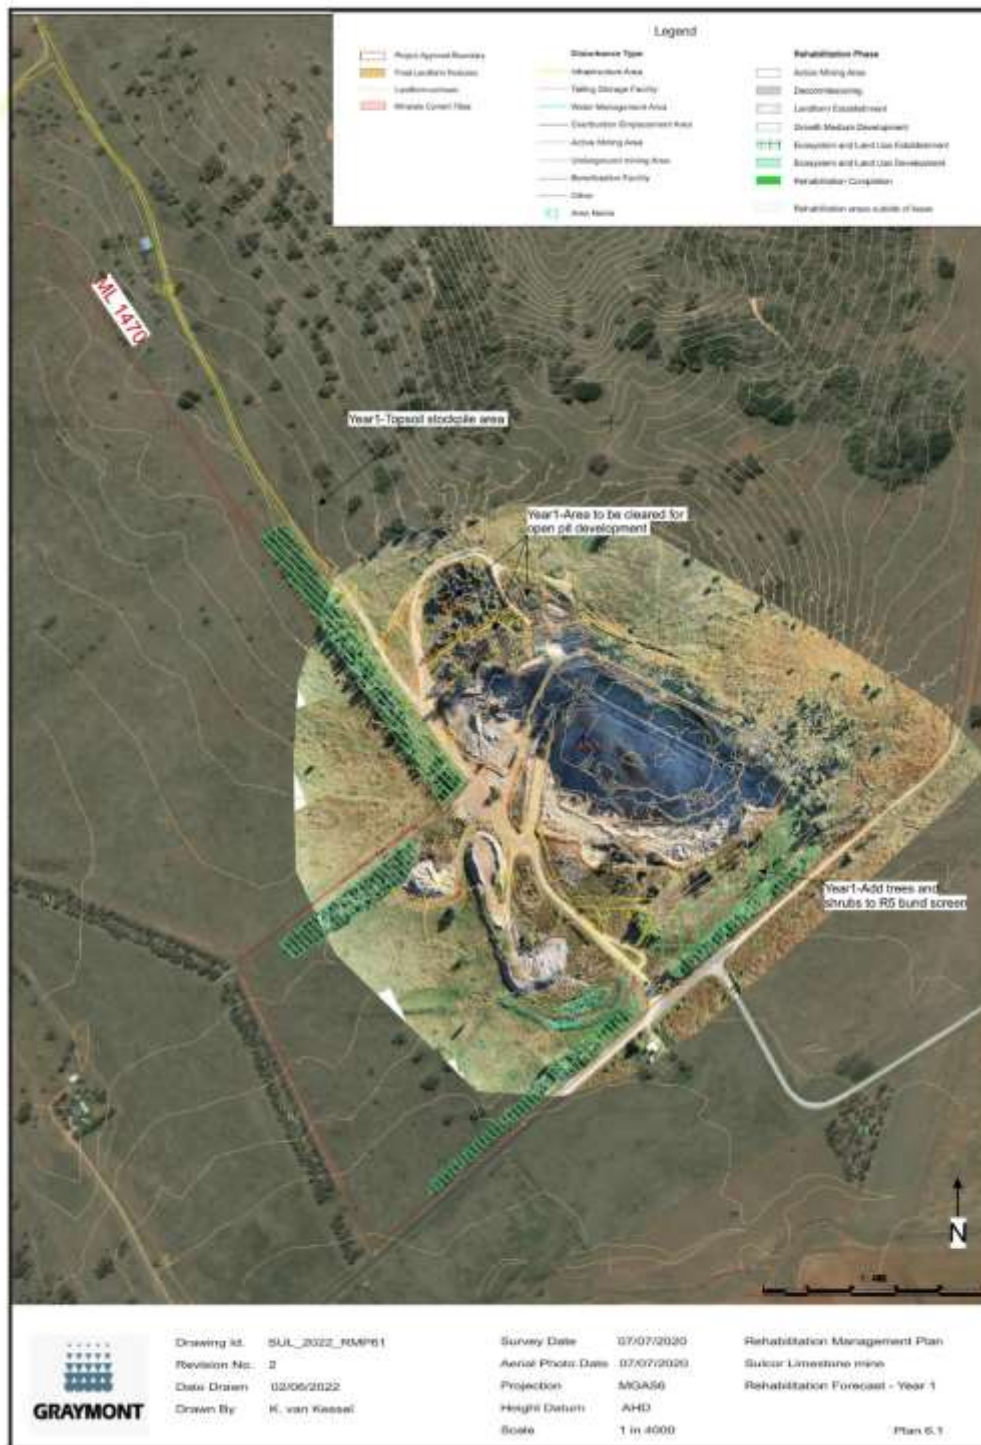
Figure 6: Rehabilitation by the end of 2022

Figure 6 shows that the rehabilitation plans for the year include no expansion of existing rehabilitation sites and no commencing of rehabilitation for mining disturbed areas. Maintenance will be performed on rehabilitation area internally identified as R5, to improve vegetation uptake. This will include sowing of new vegetation and any measures needed for soil health that are deemed necessary.

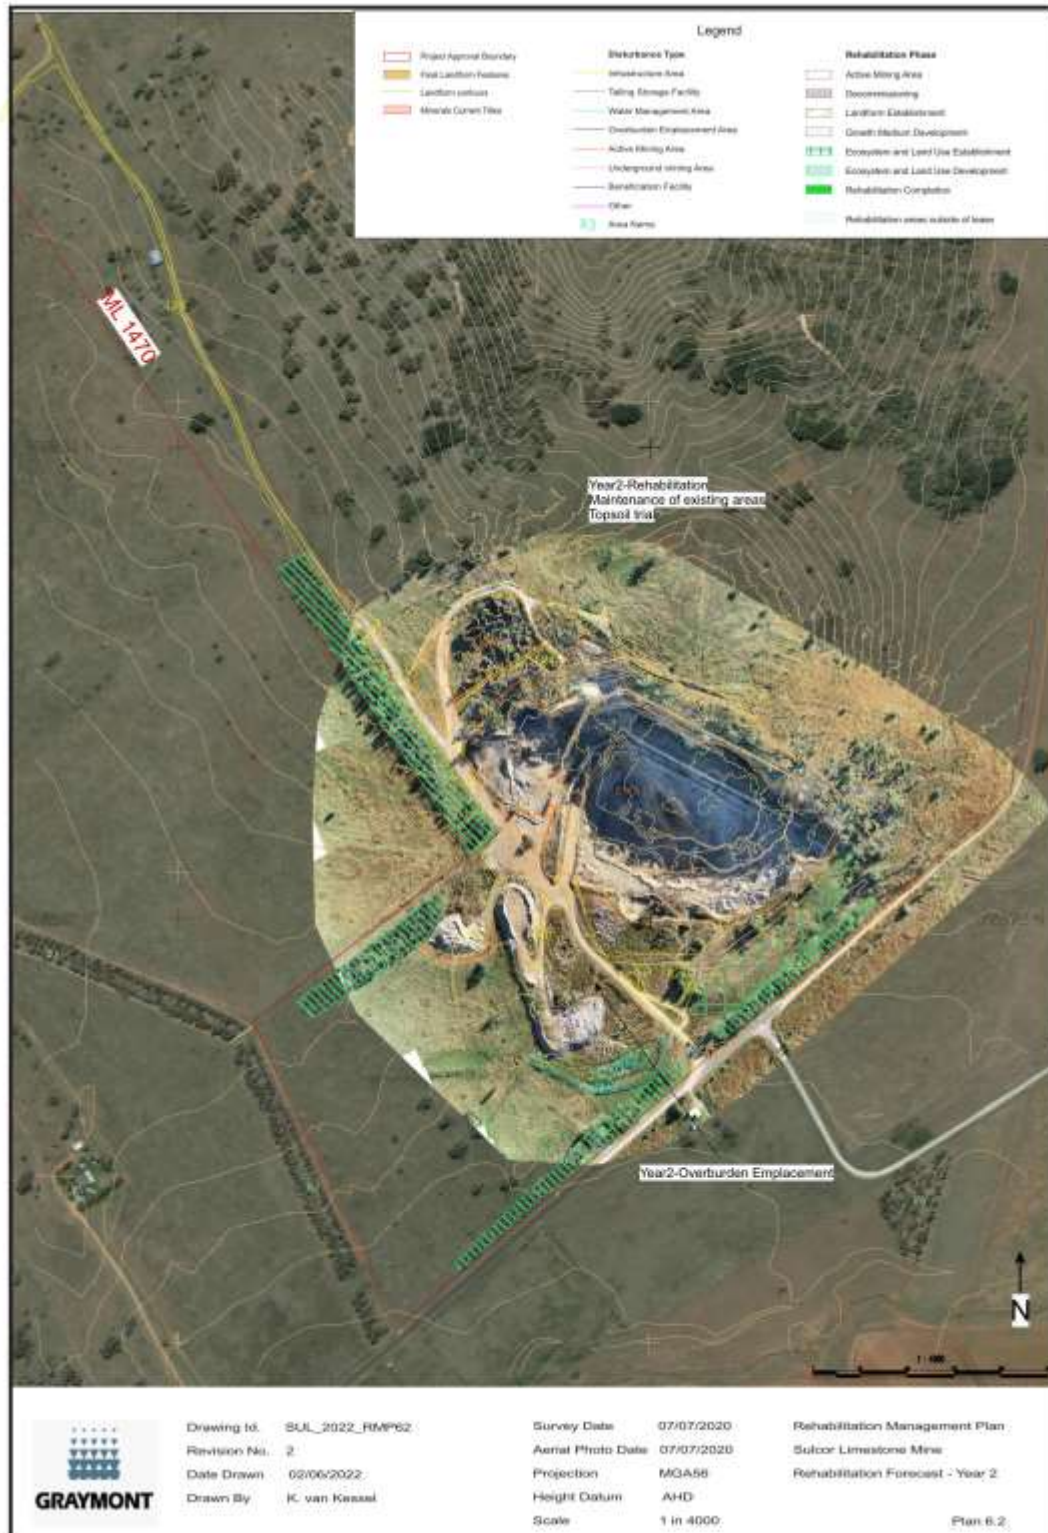
Figure 7: Rehabilitation by the end of 2023

Figure 7 shows the rehabilitation plans for 2023. This includes monitoring of environmental restoration work of R5 site to facilitate the process of further establishment.

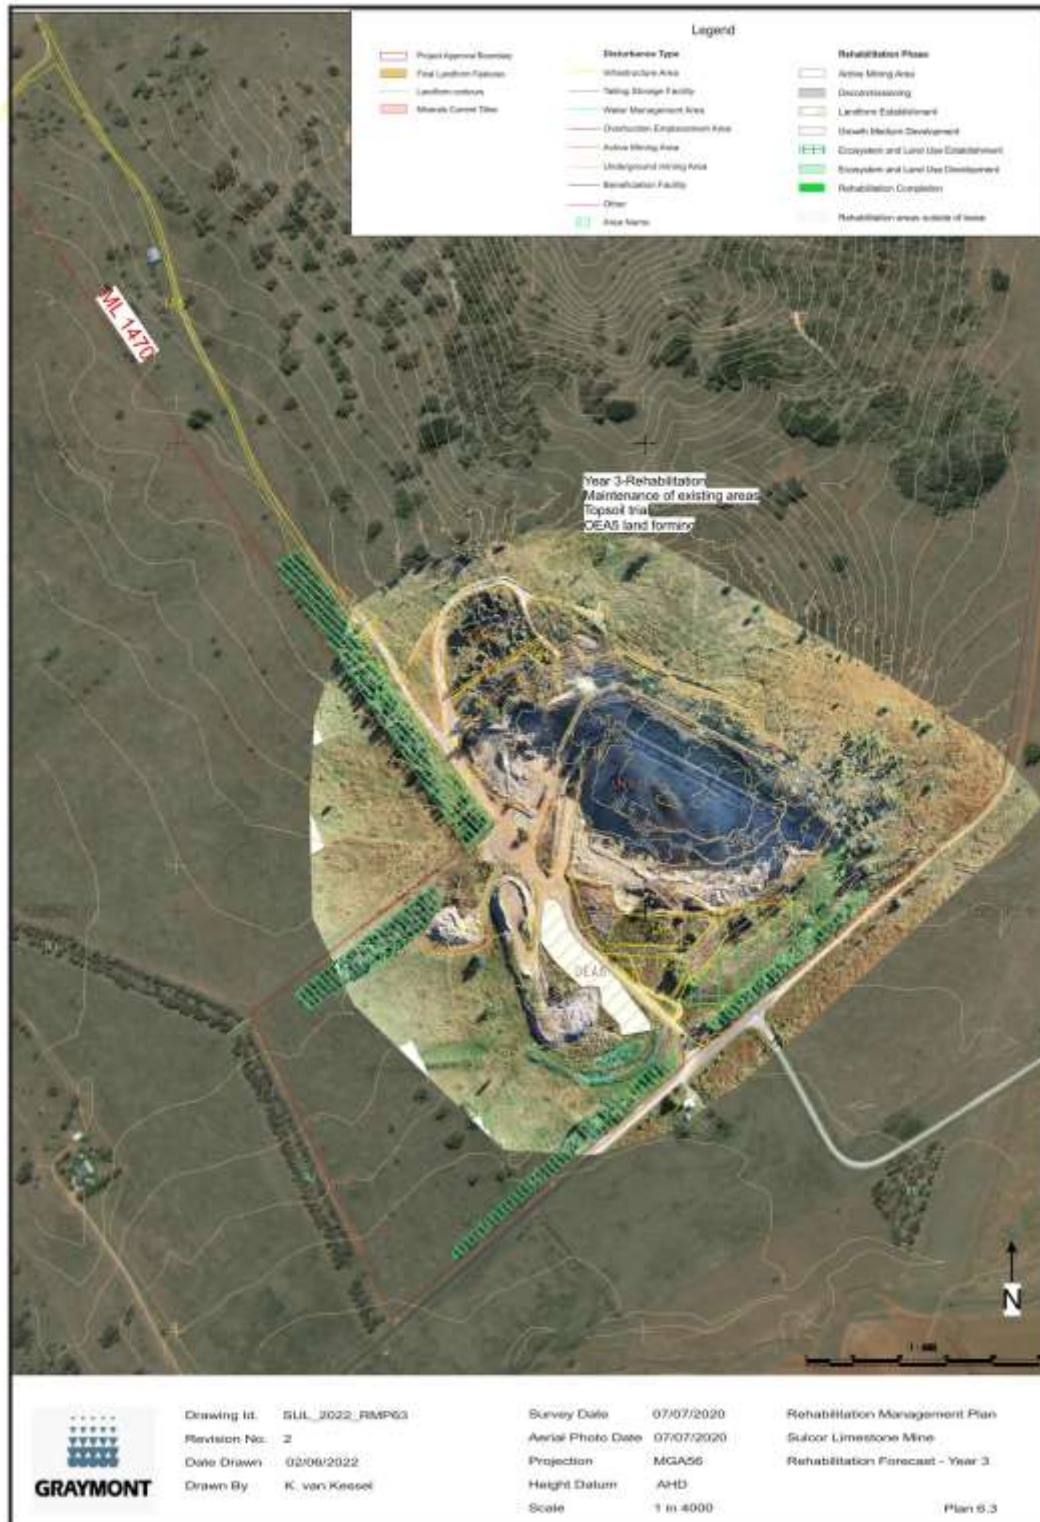
Figure 8: Rehabilitation by the end of 2024

Figure 8 shows the rehabilitation plans for 2024. This includes the commencement of the landform establishment phase for the overburden emplacement area OEA5.

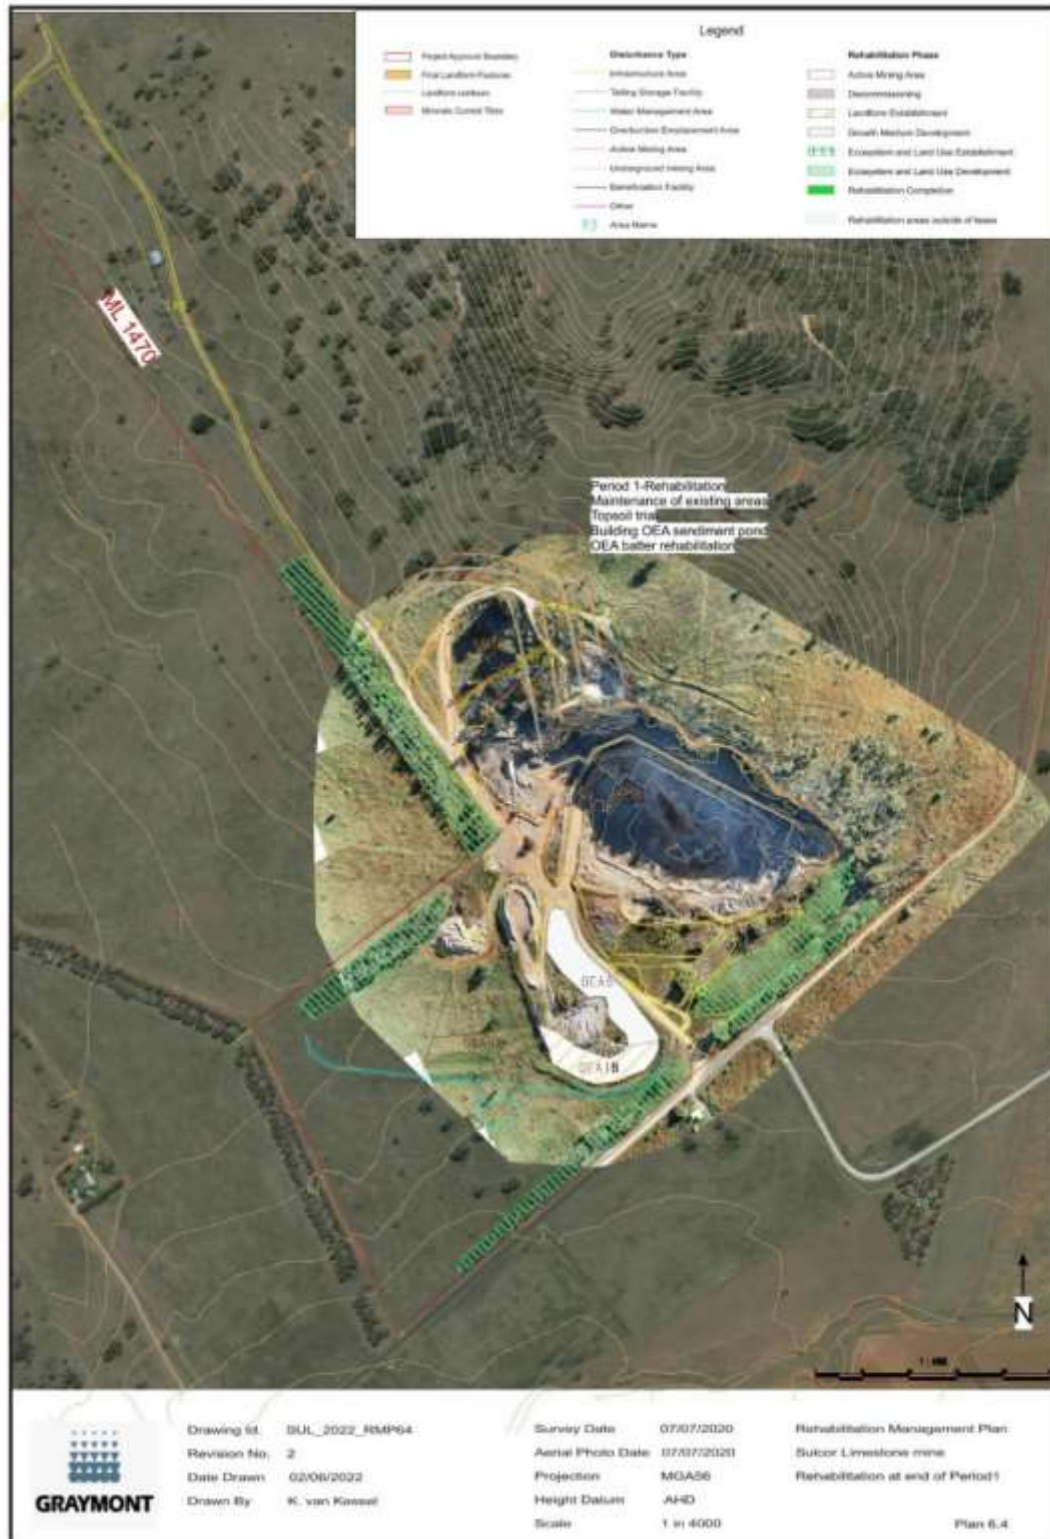
Figure 9: Rehabilitation by the end of 2027 shows the proposed rehabilitation activities to be completed by 2027. Overburden emplacement areas OEA1B and OEA5 will be in the landform establishment and growth medium development phases, respectively.

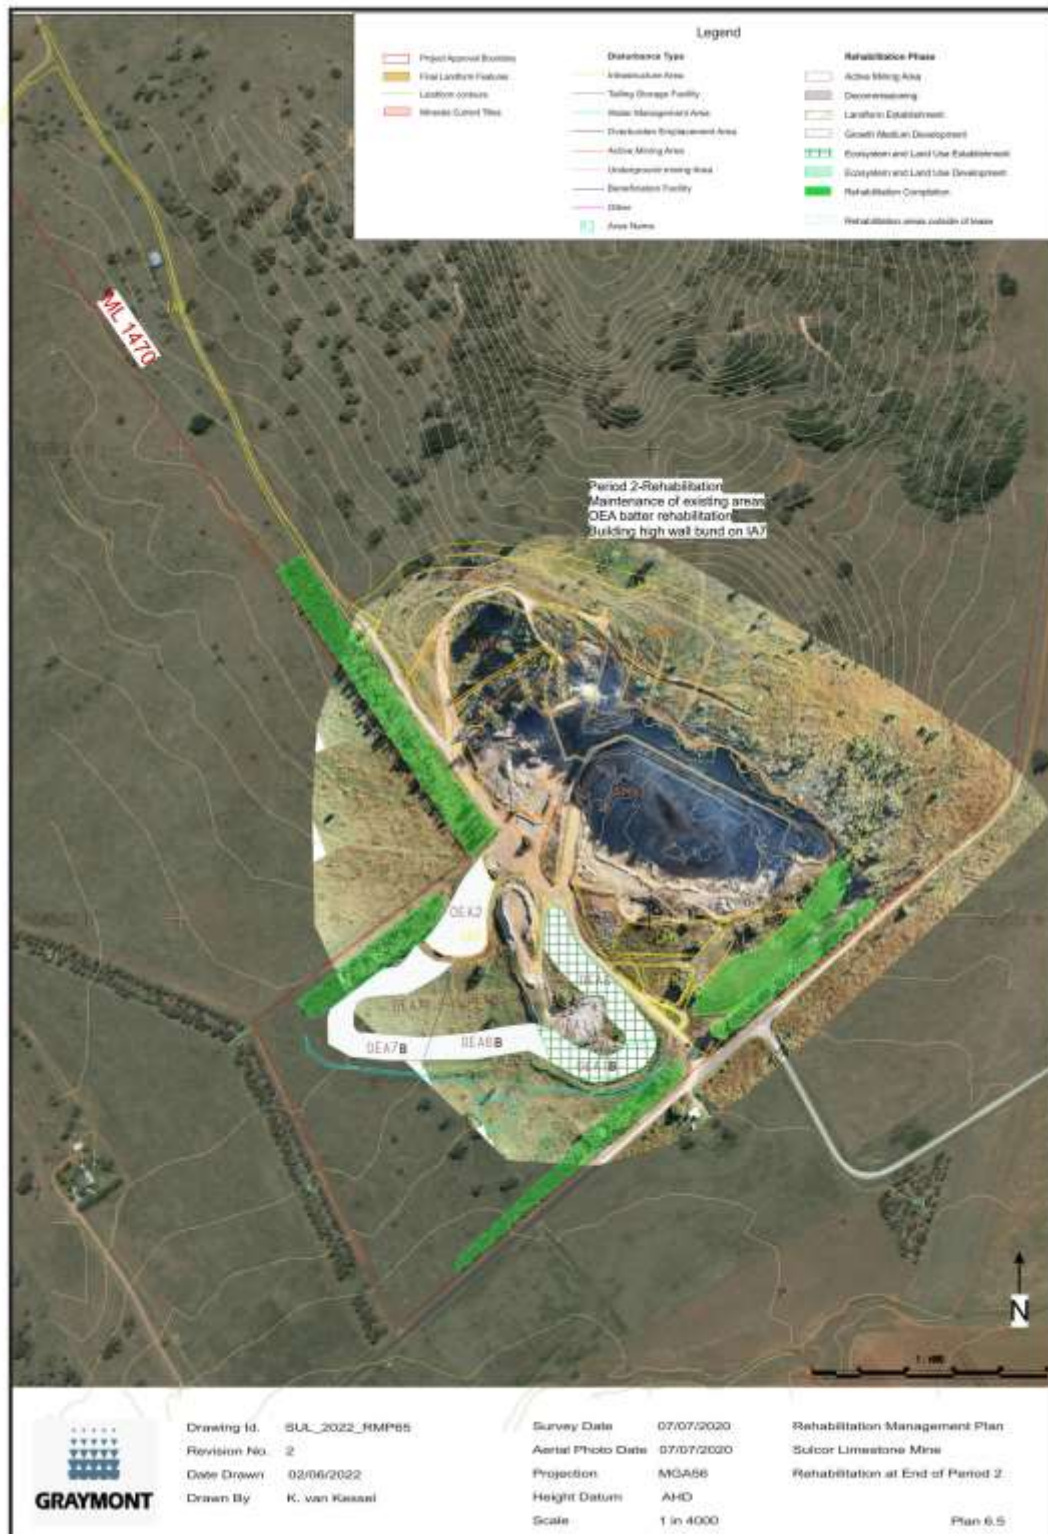
Figure 10: Rehabilitation by the end of 2032

Figure 10 shows the proposed rehabilitation activities to be completed by 2032. OEA1B and OEA5 are expected to be in the ecosystem and land use establishment phase. OEA2, OEA6B and OEA7B are intended to be in the growth medium development stage.

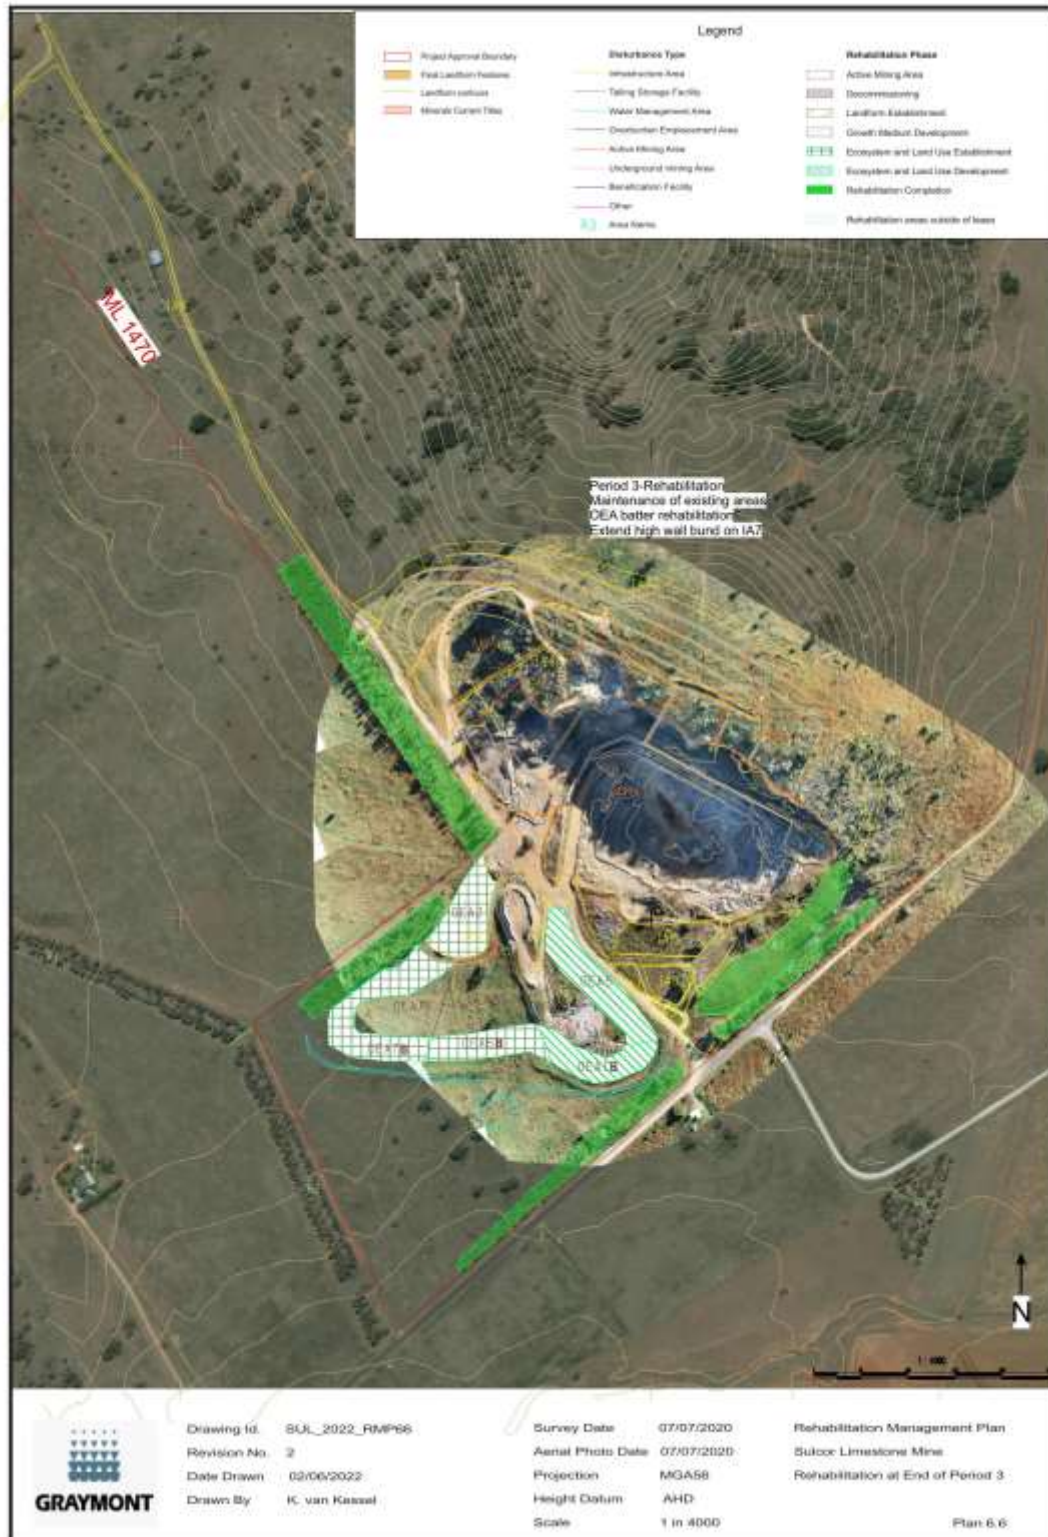
Figure 11: Rehabilitation by the end of 2037

Figure 11 shows the proposed rehabilitation activities to be completed by 2037. OEA1B and OEA5 are expected to be in the ecosystem and land use development phase. OEA2, OEA6B and OEA7B are expected to be in the ecosystem and land use establishment stage.

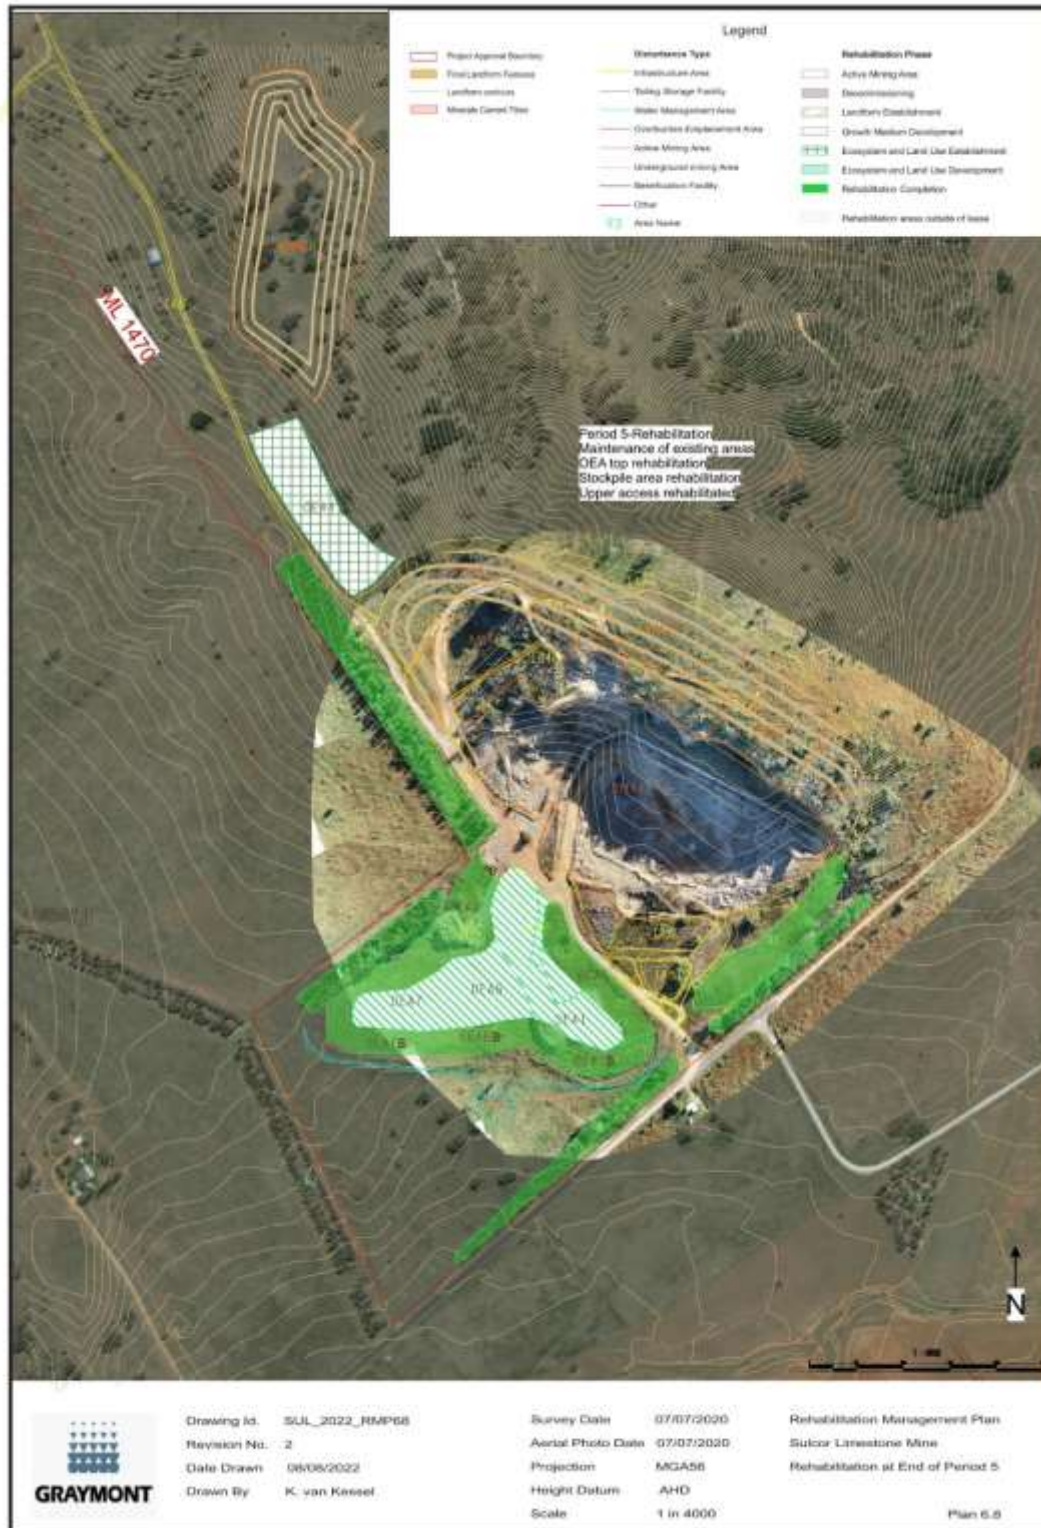
Figure 12: Rehabilitation by the end of 2042

Figure 12 shows the proposed rehabilitation activities to be completed by 2042. Overburden emplacement areas OEA1, OEA6 and OEA7 will be intended to be in the ecosystem and land use development phase, while OEA4 is intended to be in the ecosystem and land use establishment phase.

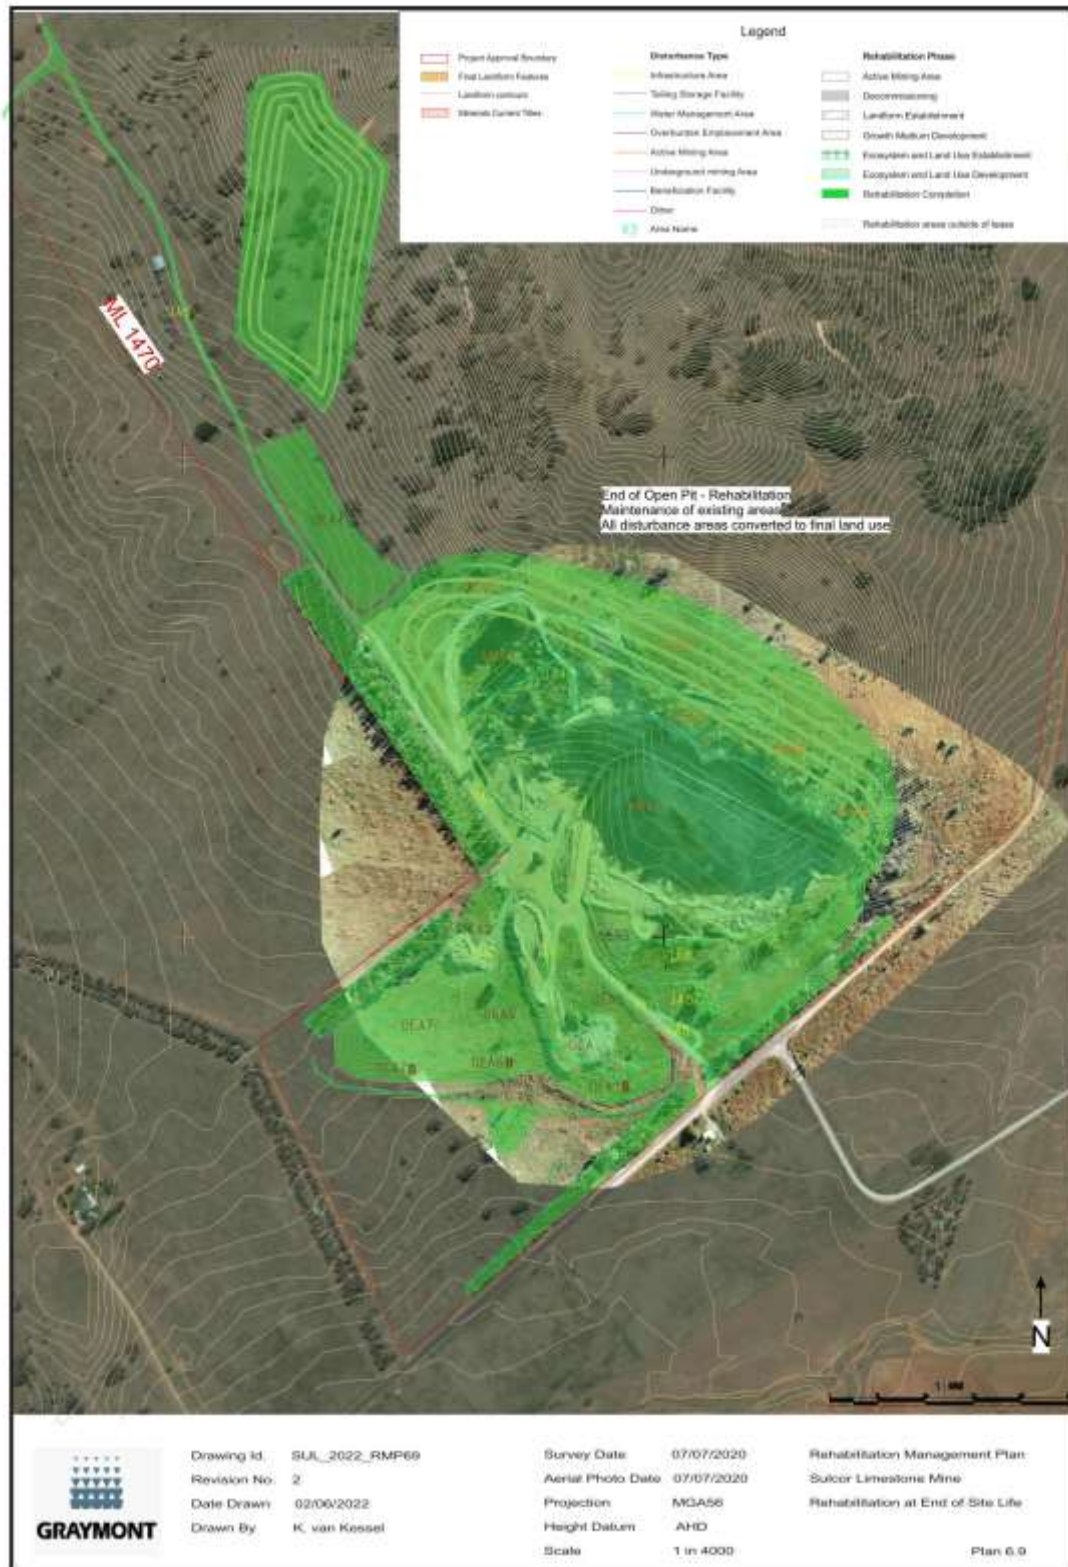
Figure 13: End of life rehabilitation by 2045

Figure 13 presents the rehabilitation schedule to be completed by the end of the year 2045. All disturbed areas are expected to be completed rehabilitated by this time.

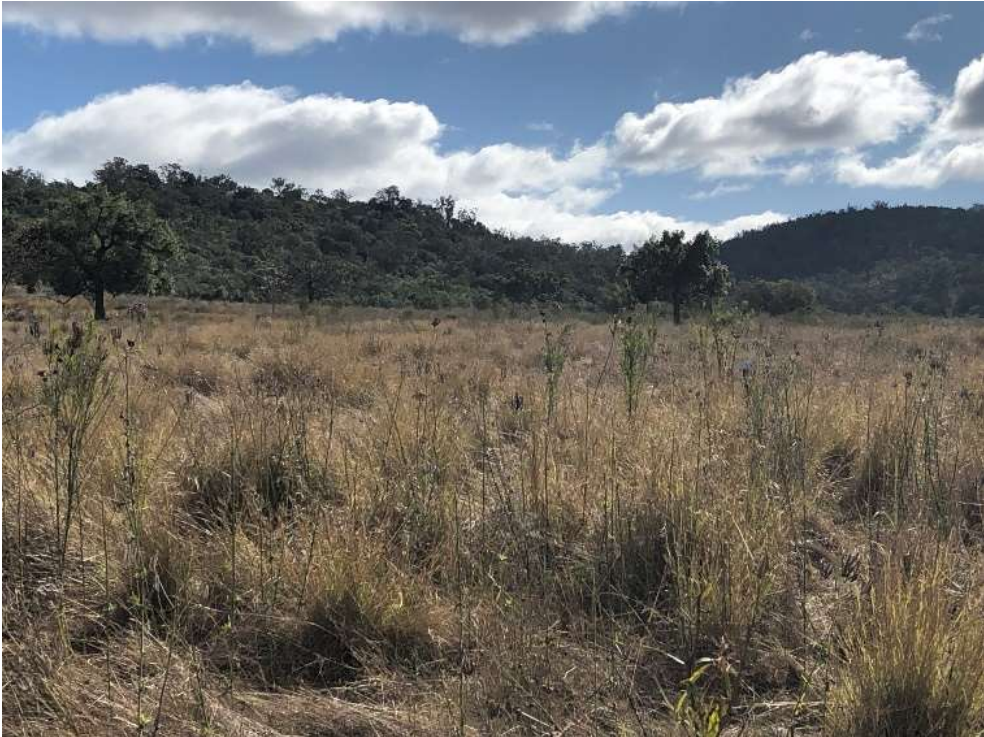
Site	Analogue site 1 (AS1)

Coordinates	56 J 0291906 : 6583329
Ecosystem Type	Grassy Woodland
Canopy / Emergent	Open Woodland (<10% tree cover). Native species such as White Box (<i>Eucalyptus aldens</i>) Black Cypress Pine (<i>Callitris endlicheri</i>), Silver-leaved Ironbark (<i>Eucalyptus melanophloia</i>) and Kurrajong (<i>Brachychiton populneus</i>) mixed with introduced species such as Peppercorn Trees (<i>Schinus mole</i>)
Shrub / Understory Layer	Minimal native shrub layer. Primarily tall introduced species such as fleabane and vervain. These are considered weeds within pasture lands and should be controlled as part of the weed management program.
Ground / Herb Layer	100% covered with mixed native and introduced species, consistent with grazing pastoral land. Species not defined.
Fallen timber (Coarse woody debris)	Very low – Occasional thin (5-10mm diameter) sticks and rare medium (10-50mm diameter) sticks

Landform	Very gentle slopes, often less than 5%. Steeper slopes toward the base of the hill where tree density increases, between 5% and 15%. Undulating hills and long convex to simple side slopes.
Soil Conditions	Soils were not surveyed

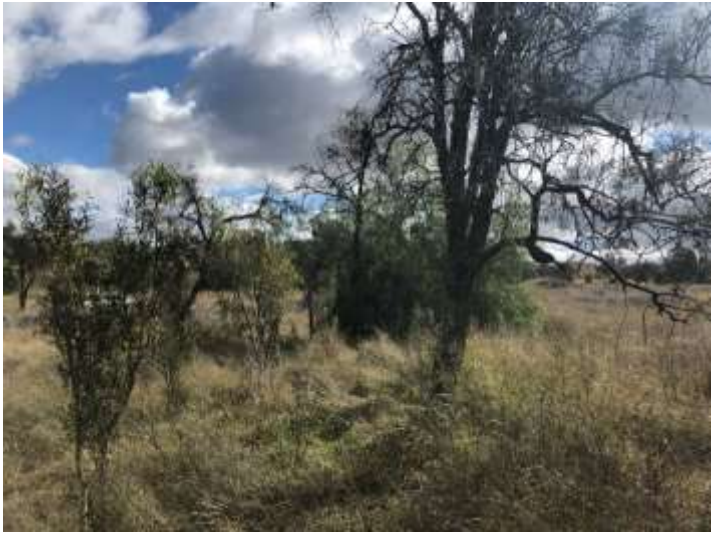
Site	Analogue site 2 (AS2)

Coordinates	56 J 0290901 : 6583406
Ecosystem Type	Woodland
Canopy / Emergent	Woodland (10-30%) cover. Native species such as White Box (<i>Eucalyptus aldens</i>), Yellow Box (<i>Eucalyptus melliodora</i>) Black Cypress Pine (<i>Callitris endlicheri</i>), Silver-leaved Ironbark (<i>Eucalyptus melanophloia</i>), numerous wattles (<i>Acacia</i> sp.) and Rough-barked apple (<i>Angophora floribunda</i>) mixed with introduced species such as Peppercorn Trees (<i>Schinus molle</i>). Canopy cover tended to be clustered close together except for larger gum trees and Angophora.
Shrub / Understory Layer	Sparse shrub layer mainly in rocky areas. Includes Sticky Hop-bush (<i>Dodonaea viscosa</i> subsp. <i>Angustifolia</i>), Native olive (<i>Notolea microcarpa</i>) and African Boxthorn (<i>Lycium ferocissimum</i>).
Ground / Herb Layer	Ground layer heavily weed impacted with Milk Thistle (<i>Silybum marianum</i>) and Fleabane (<i>Conyza subsp.</i>). Introduced Coolatai grass is widespread. Some native tussock grasses and forbs persist in small patches. 5-10% rocky ground cover with limestone.

Fallen timber (Coarse woody debris)	Common – Small, medium, and large sticks, with some large logs / fallen branches
Landform	Gentle slopes between 5 and 10%. Small sections of exposed limestone outcroppings. Higher slopes transition towards 20°, with an increase in tree density. Slope at site is listed as 5%.
Soil Conditions	Soils were not surveyed
